**The Audit Project of the Azerbaijani Sector of the Southern
Caucasian Pipeline (SCP) by local NGOs**

Final Report

“The Audit of the Reinstatement Activities along SCP”

BAKU - 2006

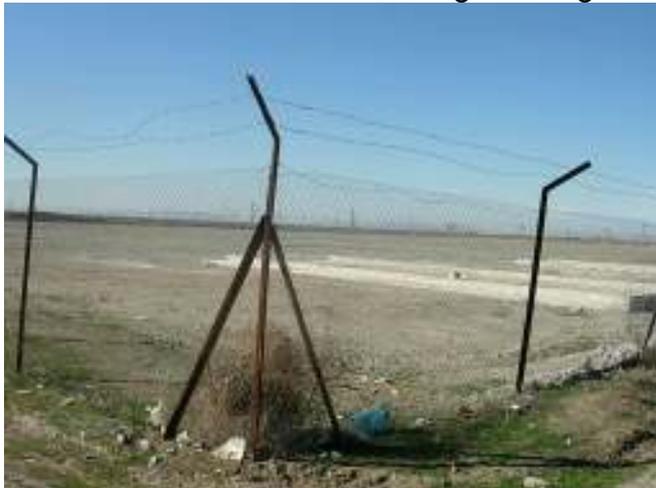
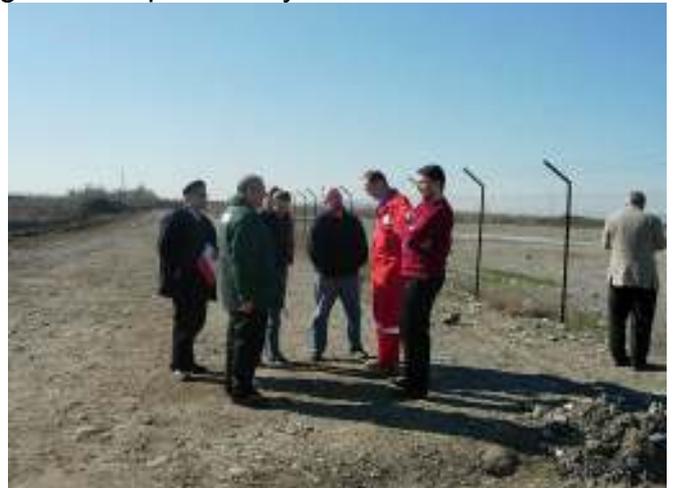
But the area hasn't been restored to its previous state. Information on the area of the camp is missing. No reply was received from the company representatives to our question about the duration of the lease agreement on the area. The people accompanying us were unaware of the implementation period. 20 cm topsoil removed from the camp area had been placed in its vicinity. The time of landscape reinstatement works to be carried out here was unknown. The duration of the final reinstatement is not clear either. According to the field inspector reinstatement in the area is not going to be carried out on a special time schedule, but rather after the completion of other works.

Photo 2. PK -237. Yevlakh camp, March 5, 2006.

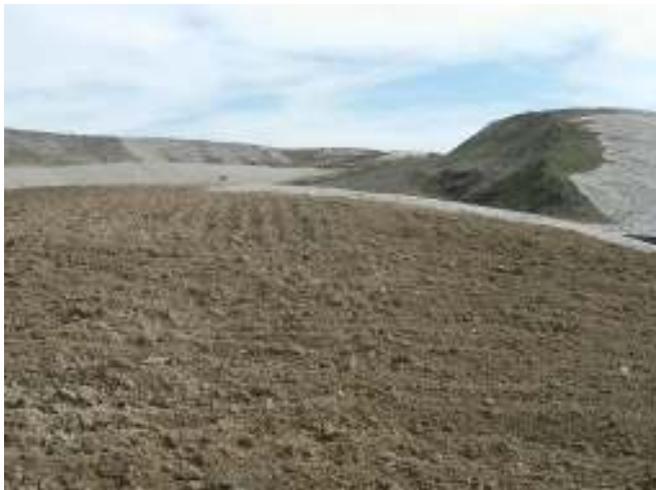
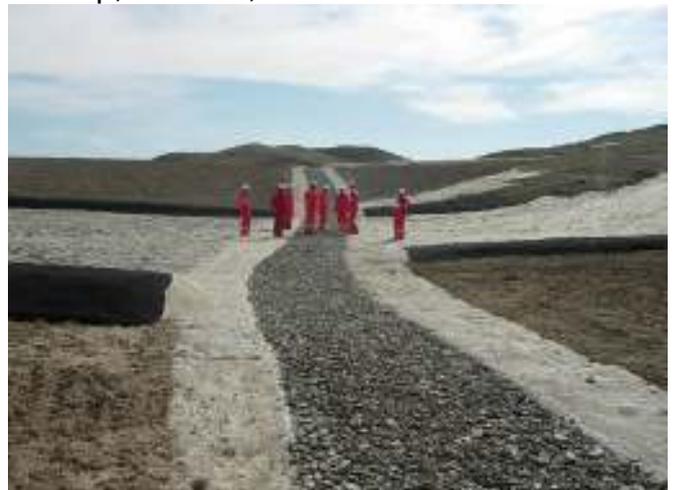
The observations at Hasansu on March 6, 2006 proved that no observation had been carried in the area since April 25, 2005, the bio-restoration hadn't been completed and the rotting nets hadn't been replaced with new ones. We consider this case a non-conformance due to its irrelevance with the stated obligation. Erosion was already obvious in Tovuzchay and Asrinchay areas since the erosion matting hadn't been properly applied.

The replacement of the rotten bionets in incomplete reinstatement areas within Hasansu hasn't been carried out according to the obligations, which in its turn increases the risk of erosion.

06.03.06. Hasan Su. The soil in the area had been leveled, but the vegetation cover hadn't been restored. The level of erosion observed in the sloping areas was 4 and more. My question on the reason of erosion was ignored.

Photo 3. Hasansu. March 6, 2006

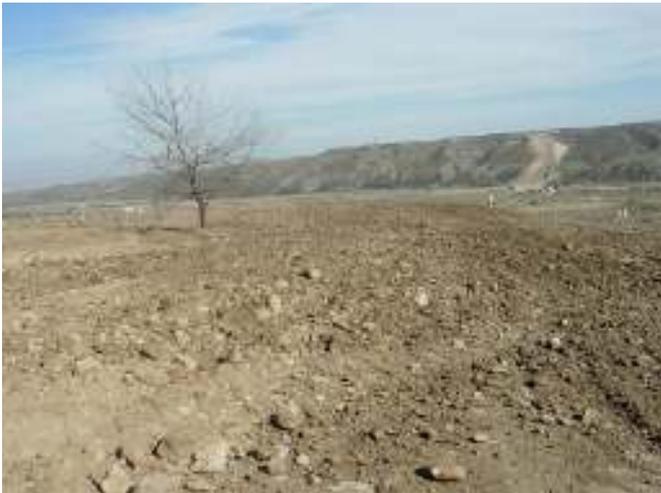
Photo 4. PK 375 Tovuzchay

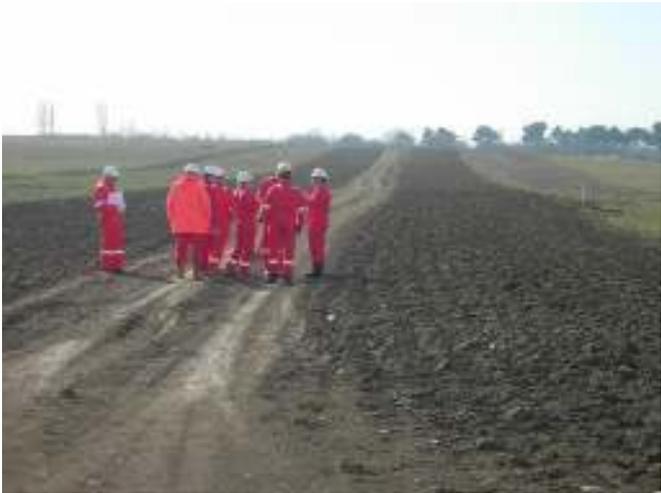
SCP obligation EN 1317 (Reinstatement SCP No 018/a AZ) states that for the purpose of eliminating furrowing, (resulting in) erosion and damage in the vicinity pipeline RoW should not be allowed to be used as a highway. The access to the site should not be permitted in the areas indicated by the company representatives:

We note the irrelevance between our observation and the undertaken obligation, since the above mentioned obligations contradict the observed situation.

Photo 5. The pipeline RoW is used as a road (PK 411) March 6, 2006

The observed case means that the works carried out along the pipeline RoW are useless. We would propose to ban the movement of vehicles along the RoW in accordance with the undertaken obligation.

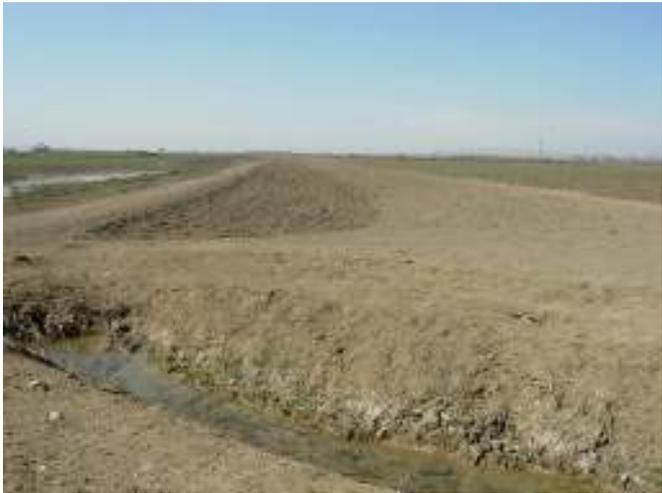
Photo 6. The pipeline RoW is used as a road (PK 430) March 6, 2006
