**BAKU-TBILISI-CEYHAN
Pipeline Project**

**Report of the Post-
Financial Close
Independent
Environmental
Consultant
Fifteenth Site Visit –
September 2013**

BNP Paribas

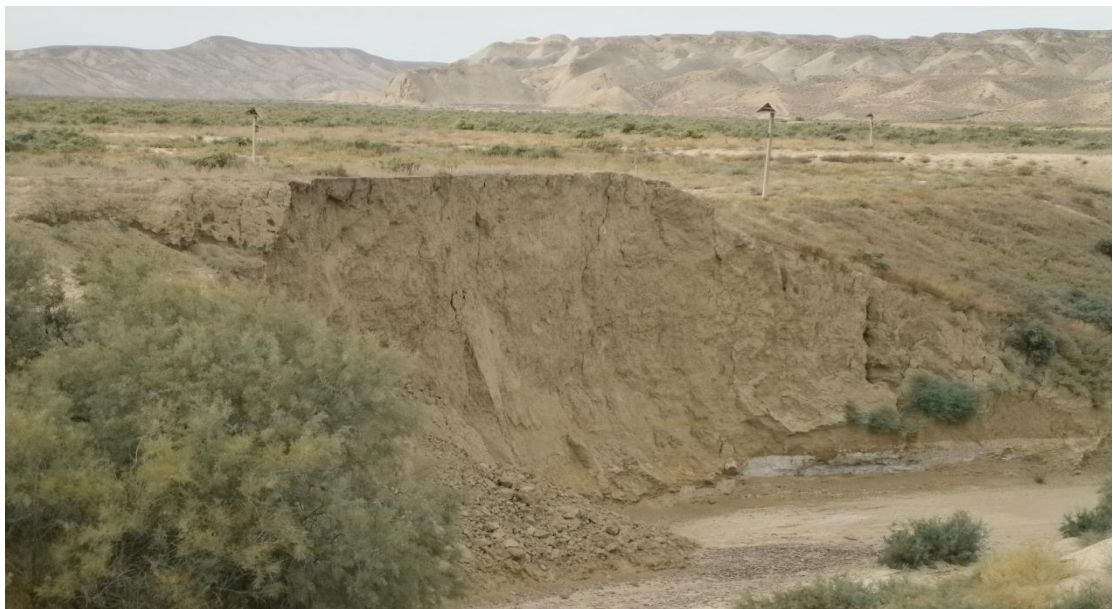
During this field visit one of the most difficult areas for river erosion, the Djeyrankechmez River crossing at KP 9, was visited (Figure 2.2). An intervention to repair the river's slopes and fix the deep erosion channels is again required. This is an area of dynamic river movements where monitoring and maintenance will always be required. The difficulties

Figure 2.2: Erosion at Djeyrankechmez River crossing

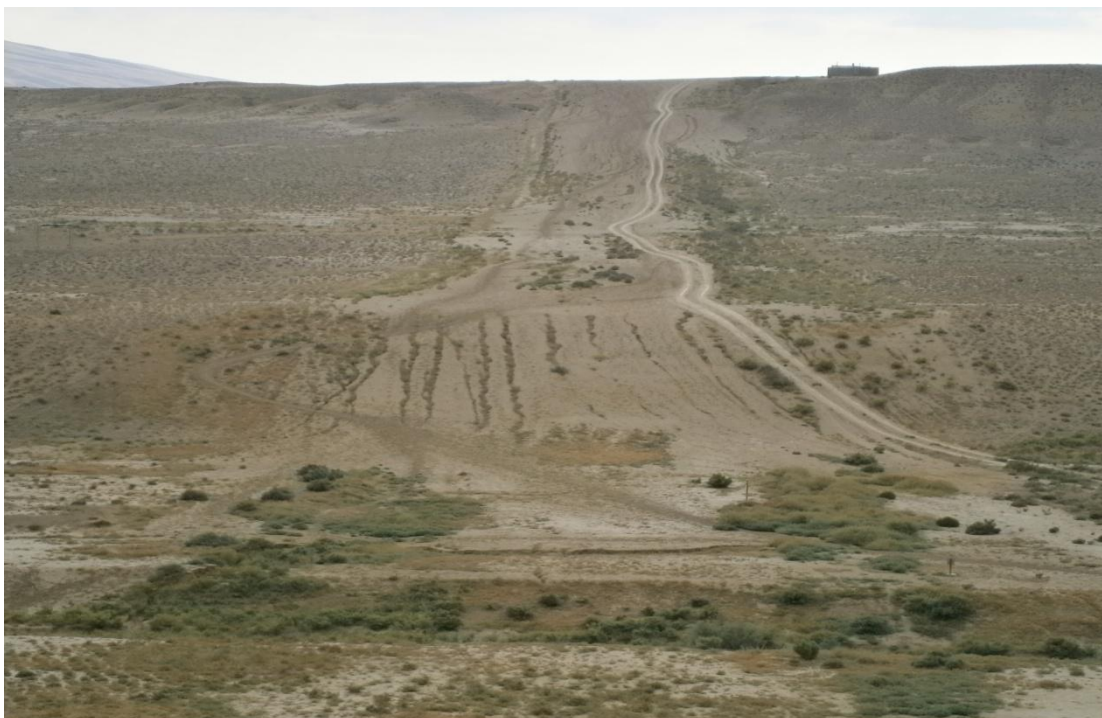
Figure 2.3: Difficult Reinstatement at KP12

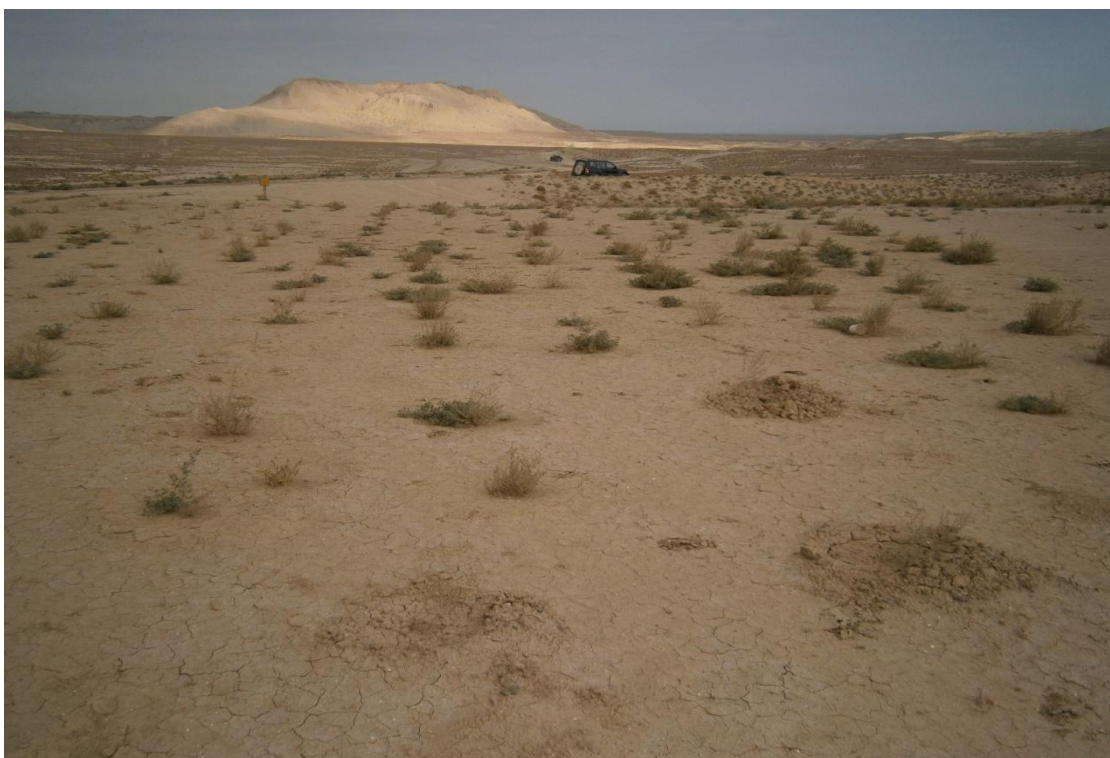
Figure 2.4: Positive Results of Recent Reinstatement near KP12

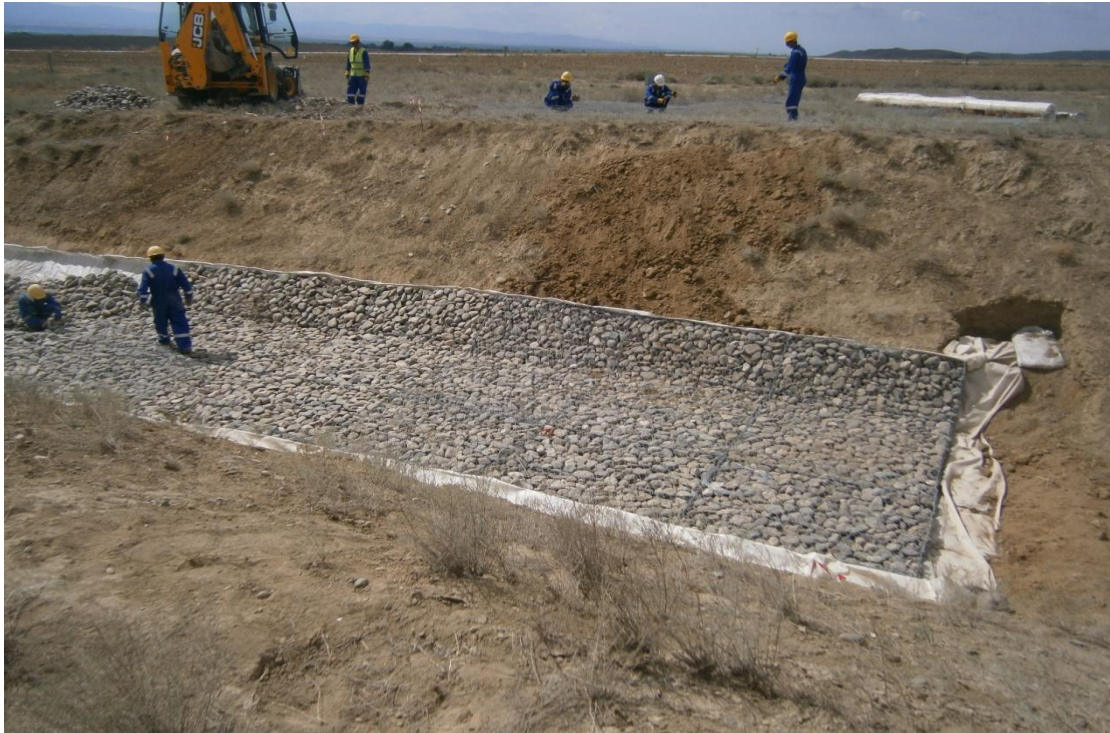
- River crossing at KP 331 at Shamkir Chai, major construction of weirs to prevent what was a serious erosion of the riverbed with potential for exposing the BTC pipe is now complete;
- River crossing on the Jail river at KP343, where gabions have been installed to prevent erosion of the banks;
- River crossing at Zayam Chai at KP 356.6, where rocks have been placed on the banks to prevent bank erosion;
- Small river crossing at KP 419.2, where gabions were being installed to prevent erosion of the river bed (see Figure 2.5);
- River crossing at KP 422 on Kurudara River near to block valve AB-21, where works on the bed of the river (installation of terraces gabions) have been made to prevent its erosion.

Figure 2.5: Gabions on River Crossing at KP 419.2

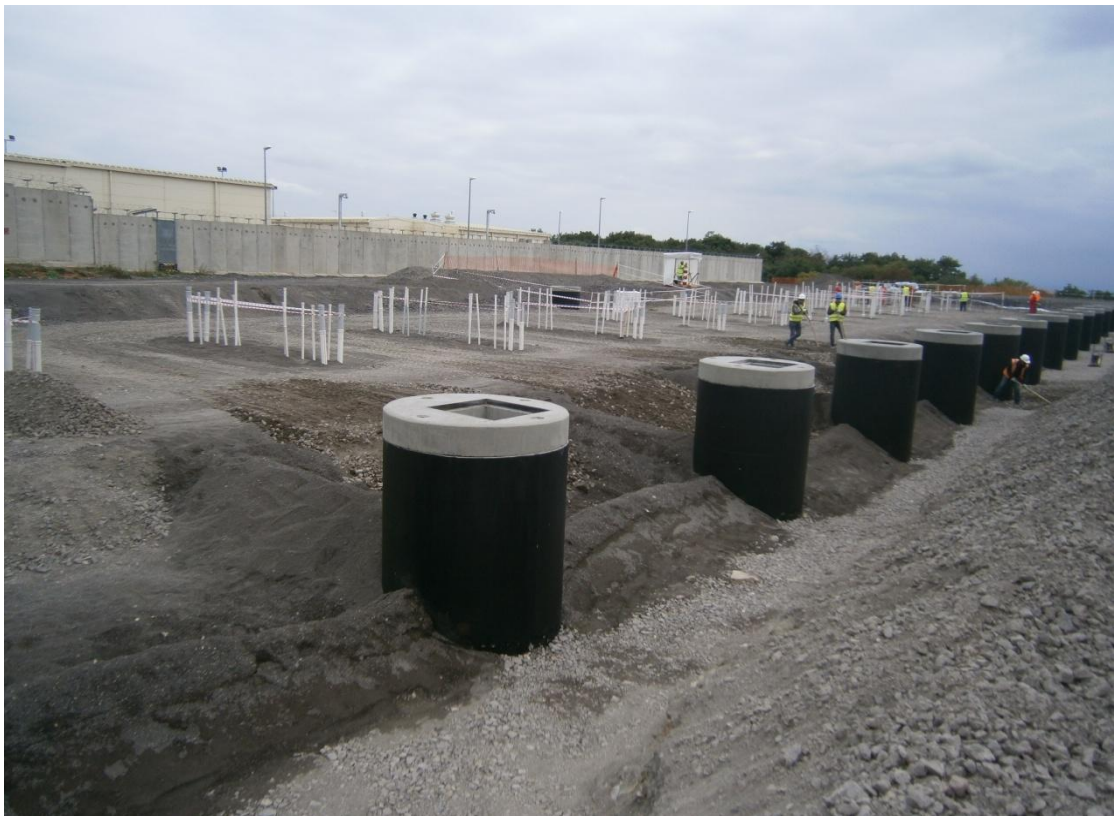
Figure 3.1: Construction initiated at PSG2 Accommodations

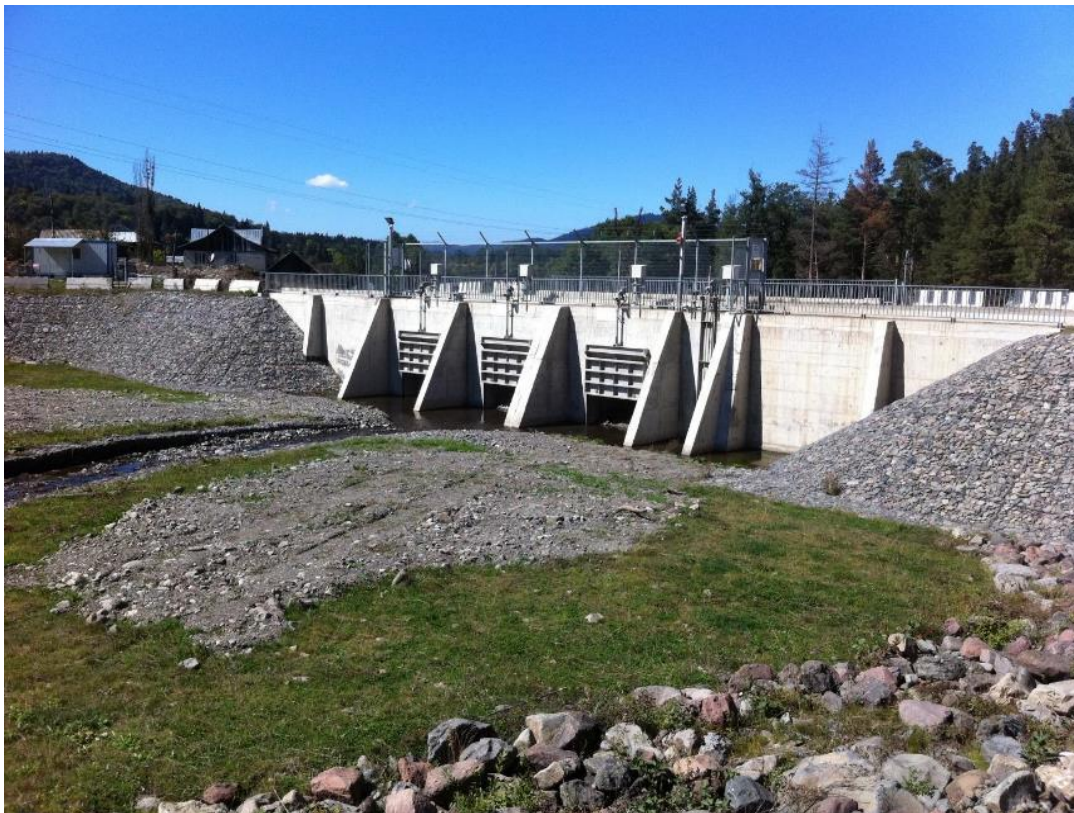
A major accomplishment of the BTC Corp. since the last IEC field visit is that the Georgian Government has accepted the Emergency Drain Down Facility (EDDF) and secondary containment facilities as complete. These projects represent an unprecedented level of spill control even when compared to worldwide best practice. The IEC Team visited the Secondary Containments of Tskhratskaro, Oshora 1, Kumiska 1 & 2, and Tori during this field visit.

Figure 3.2: Tskhratskaro Secondary Containment Facility

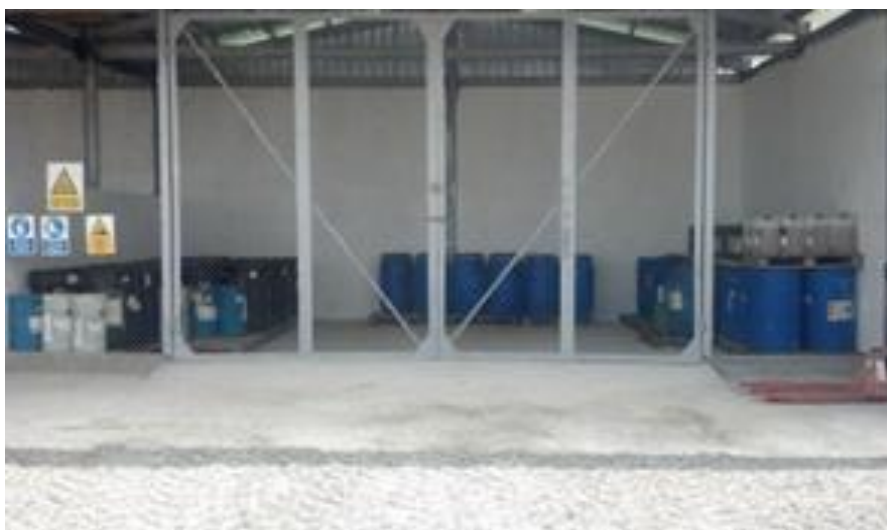
The final solution for the disposal of hazardous waste stored at the Central Waste Accumulation Area (CWAA) at PSG-1 continues to be based on international export and final disposal in EU-compliant facilities. Used oil continues to be injected into the BTC pipeline on an as-needed basis. A new chemical storage at CWAA which is now operational (Figure 3.3).

Figure 3.3: New Chemical Storage at CWAA

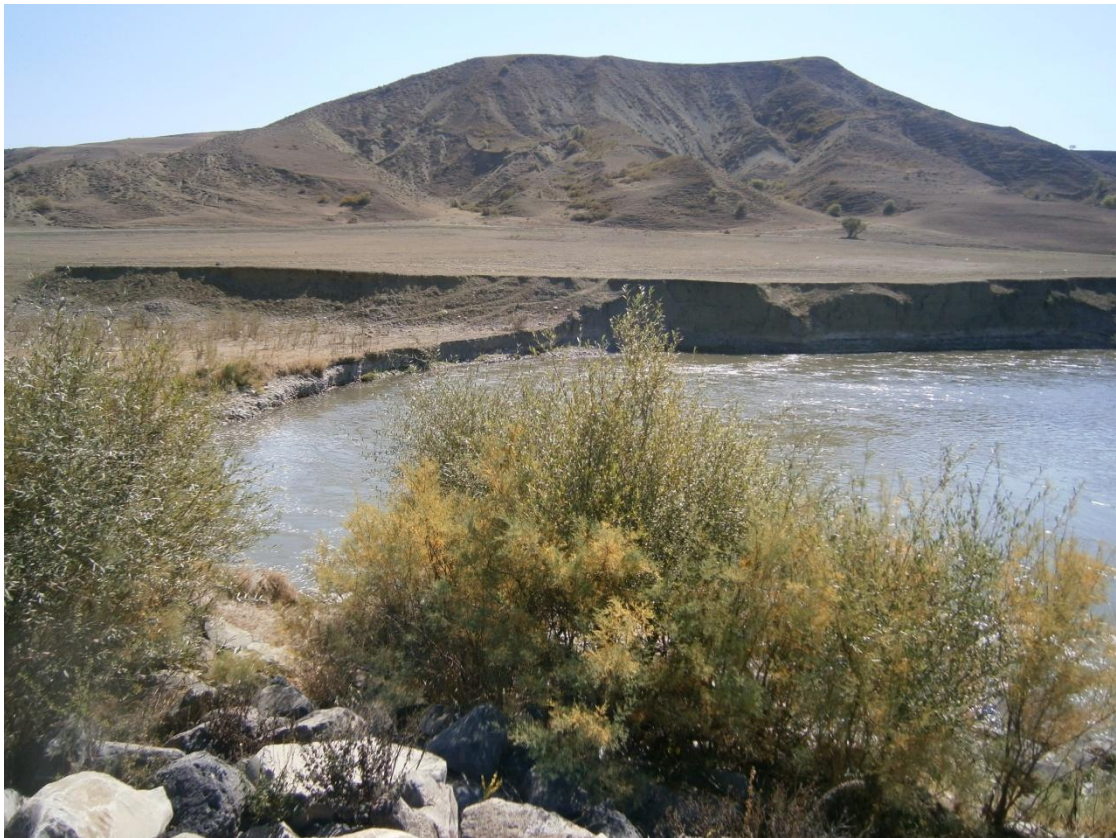
Another aspect of RoW management is preventing erosion where the pipeline could be damaged, especially at river crossings. The IEC visited the Kura River crossing at KP 222 where a rock pier intended to mitigate against the river meandering and eroding sediment over the pipeline had already been constructed, but where additional remediation was still required. The Project is well aware of the situation and currently is planning additional remedial works. The overall maintenance program for the pipeline in Georgia is well implemented

Figure 3.6: Erosion at Kura River crossing (KP 222)

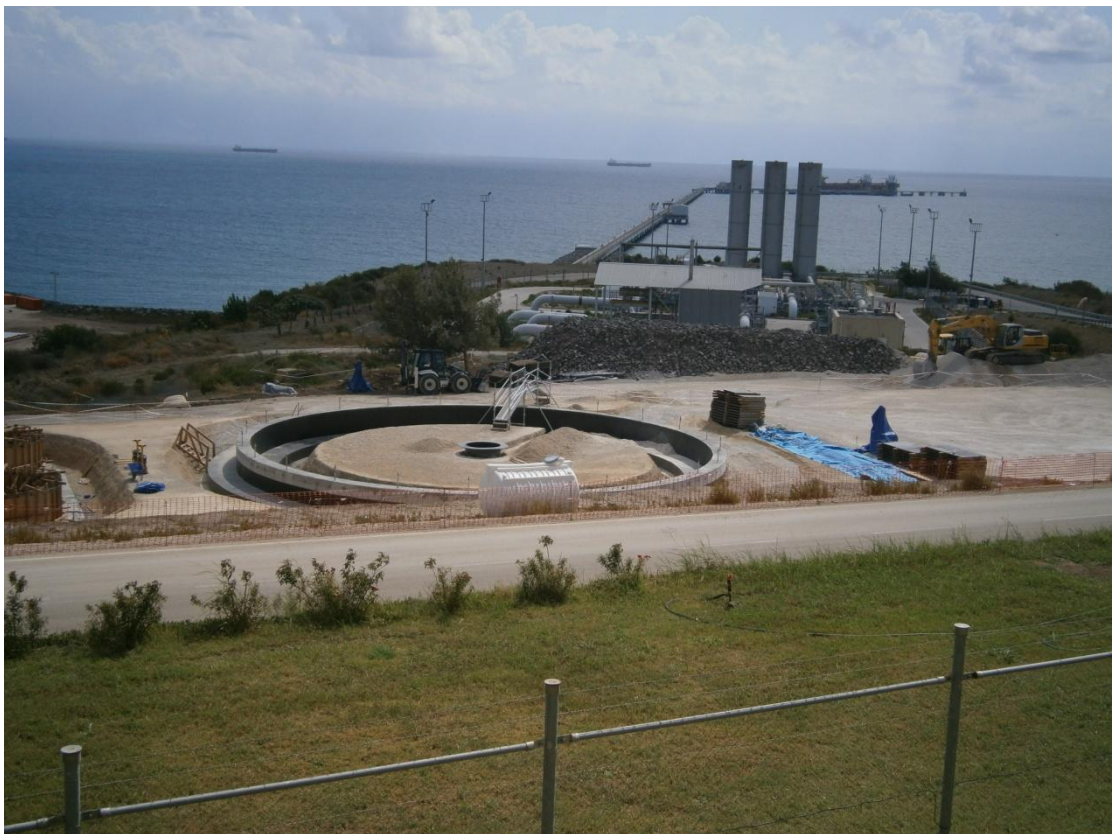
The Slops and Bilge Water Reception and Treatment Facility at the Ceyhan Marine Terminal (CMT), also known as the MARPOL Facility, is under construction expected to be complete by March 2014 (Figure 4.6). In November 2012 the Project was fined by the Turkish Ministry of Environment and Urbanization (MoEU) a second time for not building this facility and the situation was assigned as a Level II non-compliance in our report for the July 2012 site visit, so starting construction of this facility is a major accomplishment and the non-compliance is rescinded. Construction is currently ongoing (estimated 20% progress). The works have a dedicated WWTP and SWP.

Figure 4.6: MARPOL under Construction at CMT

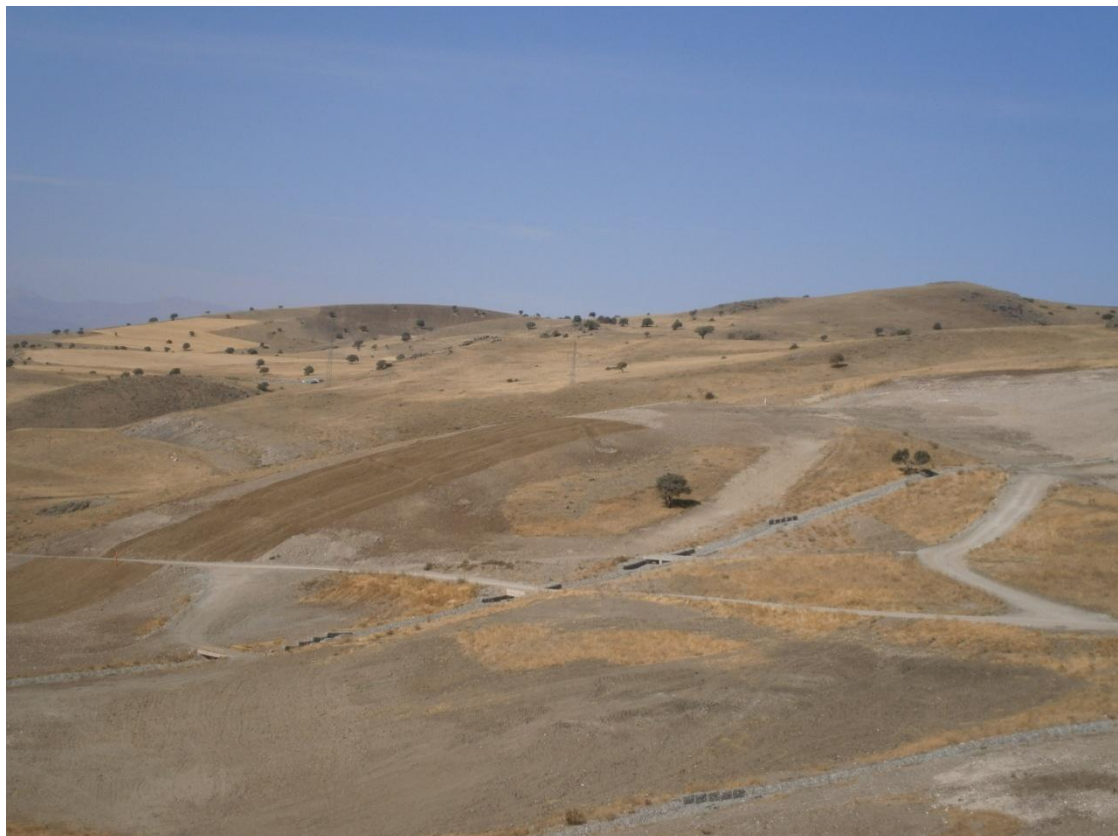
Although significant effort has been expended, the Project has not been able to control slope movements at KP1007 and plans are being made to reroute the pipeline at these sections. Another problematic area was at BVT 50, where flood control structures are needed.

Figure 4.7: Pipeline Rerouting at KP 383
