Marine Mammal / Sea Turtle Monitoring Report (PAM VSP)

Newfoundland & Labrador Orphan Basin Exploration Drilling Program

| Document Number | CN002-EV-REP-600-00011 | | |

Marine Mammal / Sea Turtle Monitoring Report (VSP)

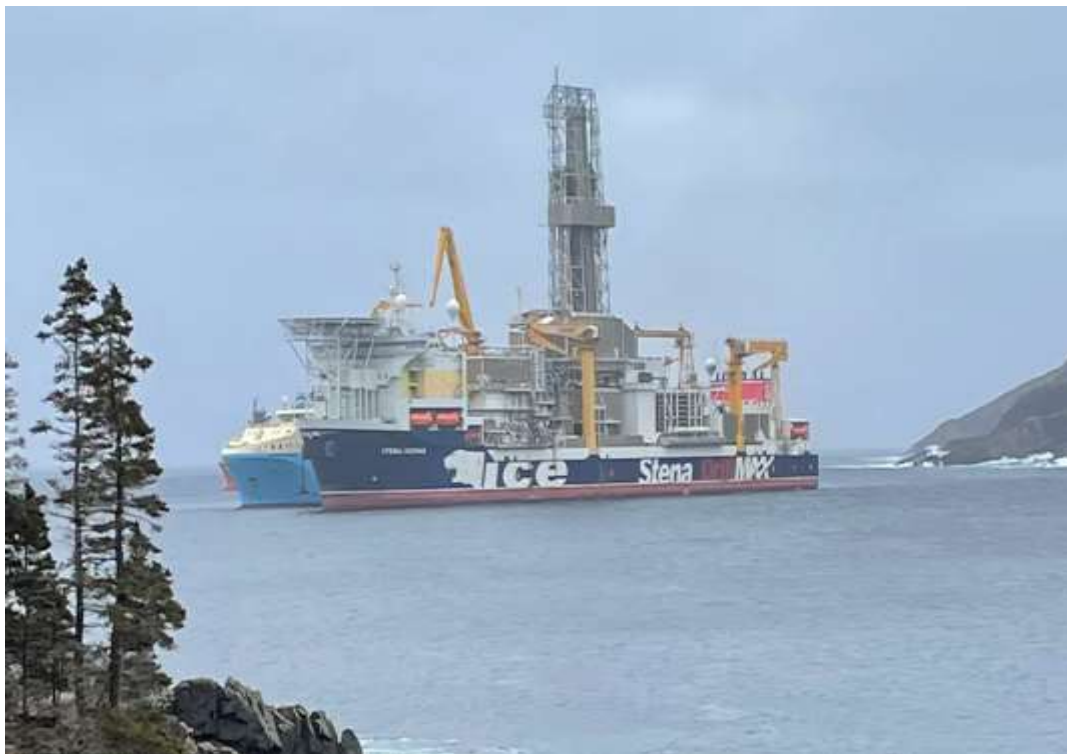
Figure 1-1: Stena IceMax

bp Canada Energy Group ULC (bp) contracted the Stena IceMax drilling vessel (Figure 1-1) to conduct an exploratory drilling program at the Ephesus wellsite in May and June 2023. The wellsite is 395 km northeast of St. John's in the West Orphan Basin in Exploration License (EL) 1168 (a consolidation of EL1145 and 1146) (Figure 1-2).

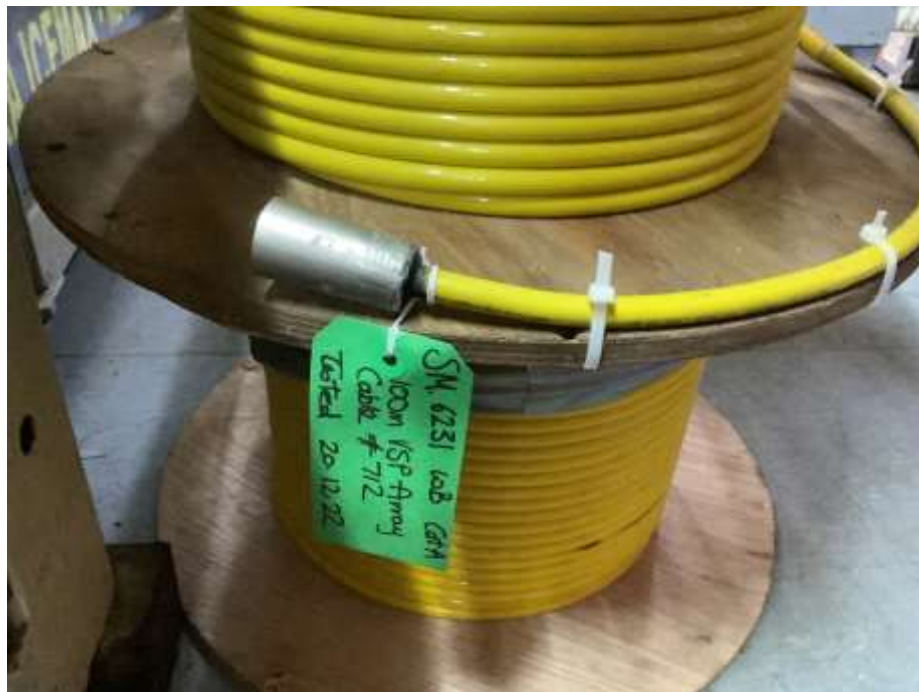
Figure 6-1: Seiche Hydrophone Cable 712

- PAMGuard software
- A buffer box, which incorporates the hydrophone interface and houses the National Instruments Data Acquisition (NI DAQ) sound card (to monitor mid-frequency to high-frequency vocalizations)
- The Behringer UMC202HD USB sound card (to monitor low-frequency to mid-frequency vocalizations)
- Intel NUC mini-PCs
- Display monitors/keyboards
- Cables and adapters
- Two 100-meter cables (one primary and one spare) with a single hydrophone element

(acoustic sensitivity range from 20 Hz – 150 kHz) located at the terminal end of each cable

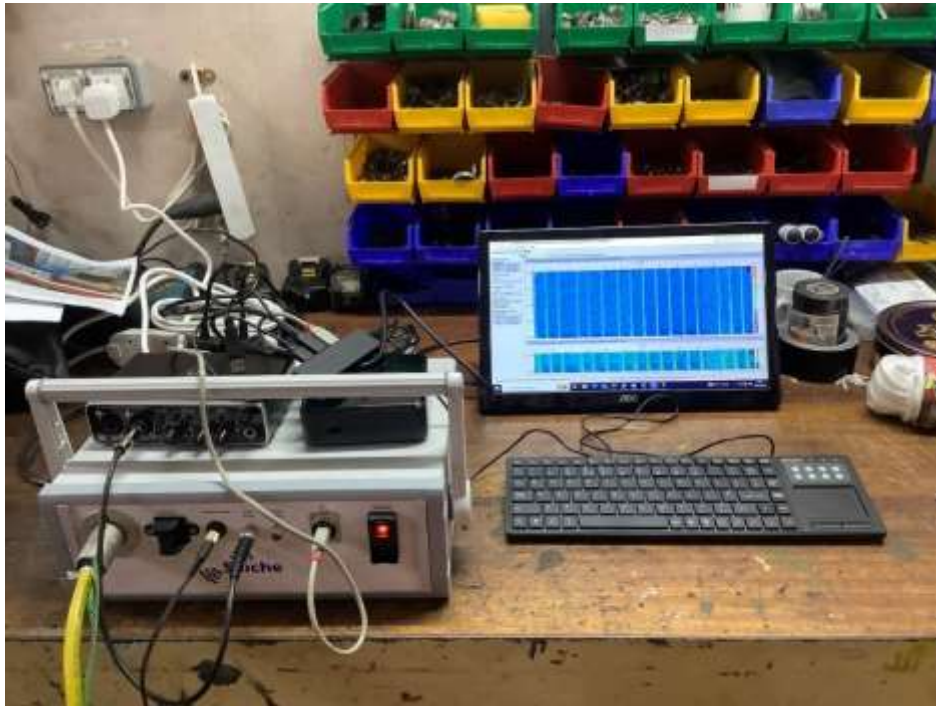
Figure 6-2: PAMGuard VSP Configuration - Hydrophone Tap Test Detections Displayed Across the Full Frequency Range of the Main Spectrogram Display

The Intel NUC mini-PCs were pre-installed with PAMGuard, including a ready-to-use PAMGuard configuration file suitable for VSP operations. Once all electronic equipment was set up and connected, the main hydrophone cable (SM 6231; Cable #712; Figure 6-1) was connected to the buffer box and tap tested while monitoring the visual displays in PAMGuard (i.e., the spectrogram and the click detectors). The acoustic inputs (taps and scrapes) were detected and displayed on PAMGuard visual displays (Figure 6-2), and the sound was clear in the headphones throughout the tap test. The spare hydrophone cable was also tested with the same result. The hydrophone and cable were deployed through the inactive ROV moon pool in a quality configuration and a clear signal was confirmed both aurally and visually via PAMGuard displays.

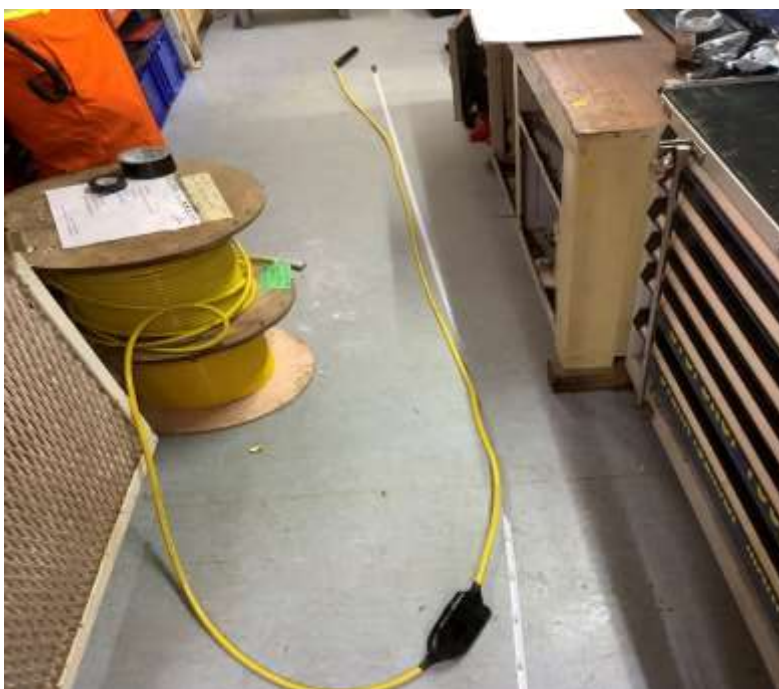
Figure 6-3: 1kg Weight Secured to Hydrophone Cable 712

Prior to cable deployment, the most efficient cable run (in terms of distance and minimizing cable tension) from the VPAM monitoring station to the hydrophone deployment location next to the inactive ROV moon pool was determined. After measuring the distance of the decided cable route, it determined that the 100m cable length would be sufficient, and an intermediate deck cable would not be required. The hydrophone cable was measured from the hydrophone element and marked with electrical tape every 10m up to 30m to be able to achieve the required hydrophone depth easily. A 1kg weight was secured to the cable 3 meters above the hydrophone element (Figure 6-3) to keep it at an appropriate depth for marine mammal detection.

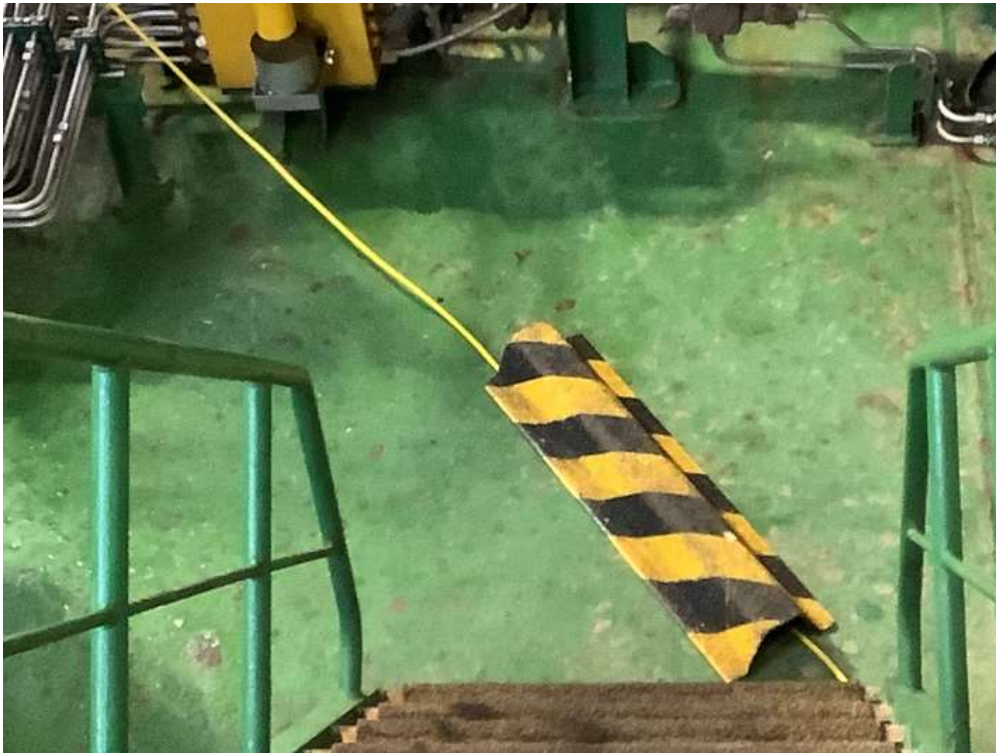
Figure 6-4: Cover to Minimize Cable Damage and Tripping Hazards.

The 100m cable was run from the VPAM station to the deployment location. Covers were placed along the cable to minimize the risk of cable damage or creating a tripping hazard (Figure 6-4). The hydrophone cable was deployed down a hatch leading to the inactive ROV moon pool to prevent entanglement with other equipment. The cable was deployed within the 500m safety zone, 103m from the source deployment location. It was deployed at a depth of 21m well under the hull of the vessel to minimize vessel noise and other ambient noise. A 1kg weight was attached 3m above the hydrophone element prior to deployment to maintain a consistent depth. Once the hydrophone element was deployed at the required depth, the cable was secured to a section of rope via a Chinese finger knot (Roman sandal tie), which was attached to a shackle around a secure rail (Figure 6-5). A section of pipe was secured above the hatch opening to protect the cable from abrasion (Figure 6-6).

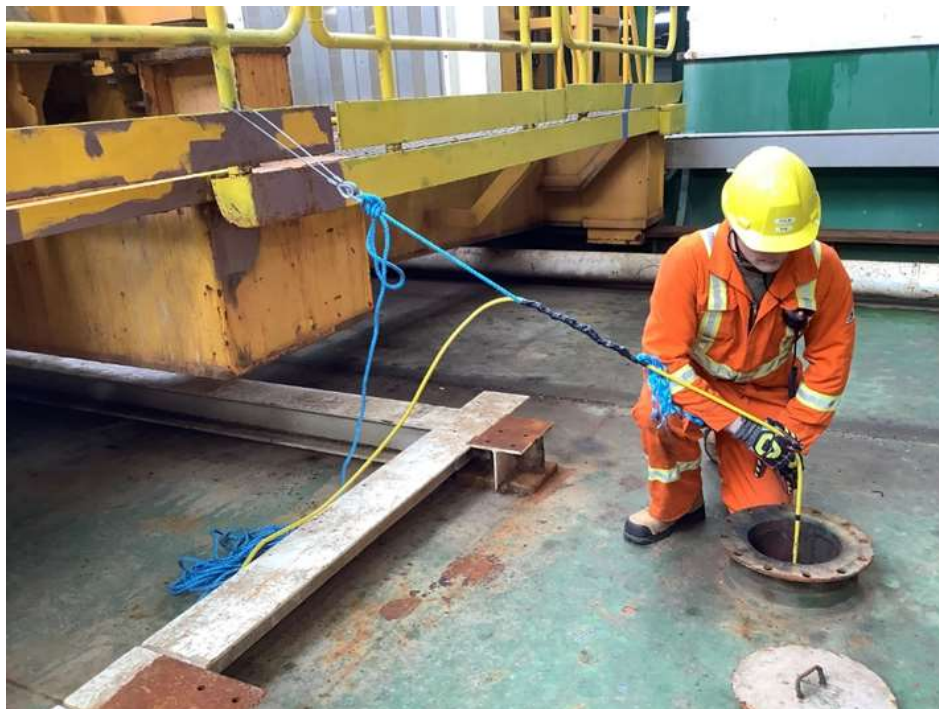
Figure 6-5: Cable Secured to the Rope Using a Chinese Finger Knot (Roman Sandal Tie) to Reduce Cable Tension.

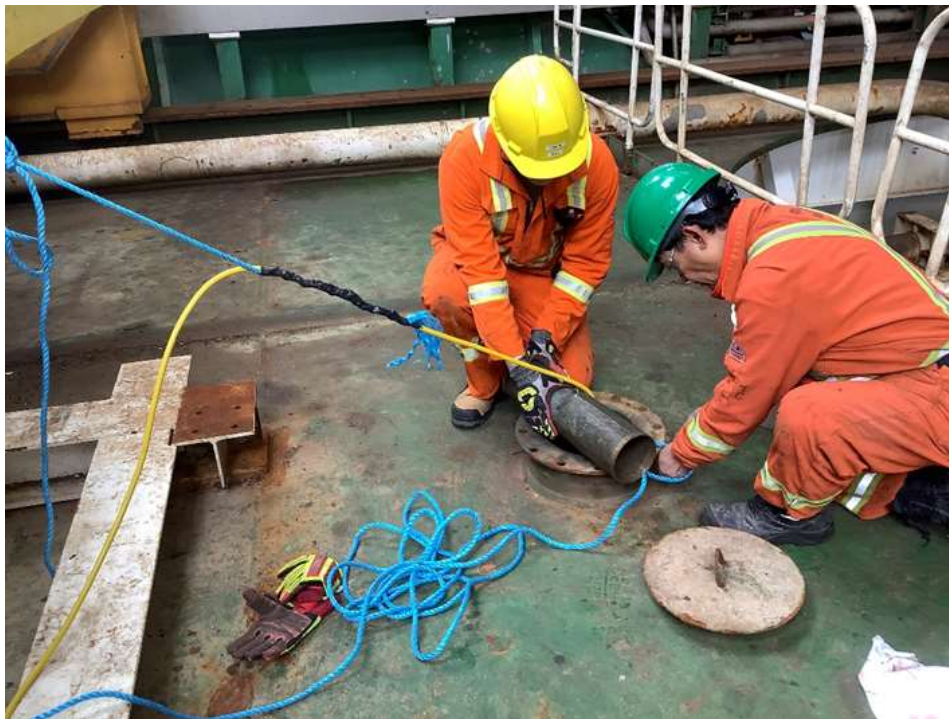
Figure 6-6: Pipe Used to Prevent Cable Abrasion and Keep the Cable Vertical
