Learning Advisory

Cellar Grating Learnings

Publication Date: December 19, 2025

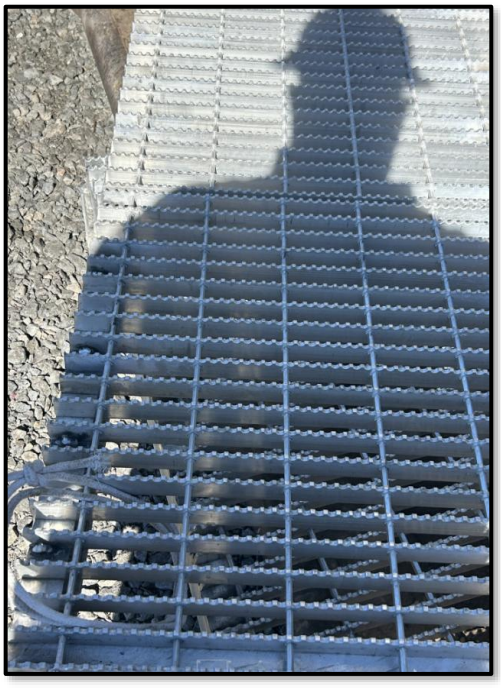
While securing the wellhead after a production cement job, an employee's foot went through the cellar cover grating, causing the employee to fall over sideways and strike their rib area. The employee was taken for medical evaluation and was released to return to work with no restrictions.

- The cellar covers were made from lightweight grating for easier handling, but this material was inadequate for the intended use. The cellar covers were reinforced with a more durable grating to prevent this type of incident from happening again.

Figure 1: Cellar cover grating before incident

- Evaluate your sites and verify they have heavy duty grating over any openings. If the material is questionable, remove and replace it with sturdy material that can support the maximum intended load for that surface to prevent a similar incident.
