**The Audit Project of the Azerbaijani Sector of the Southern
Caucasian Pipeline (SCP) by local NGOs**

Final Report

“The Audit of the Reinstatement Activities along SCP”

BAKU - 2006

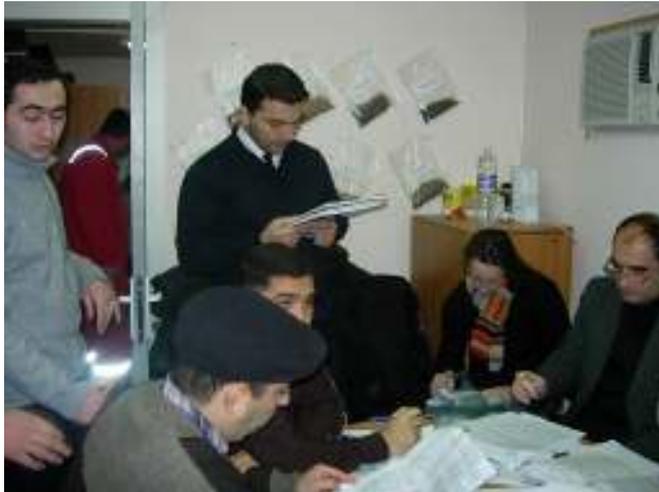
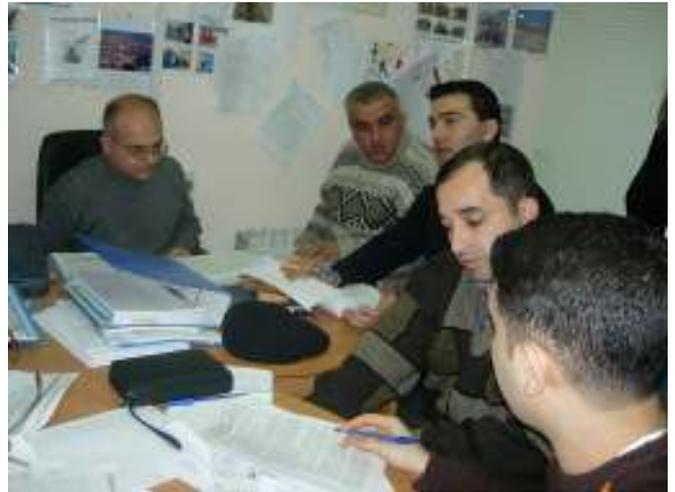
During the site visit to the Mughan camp on January 25, 2006, it turned out that the workers at the camp didn't have copies of such documents (see Appendix 4, photo 1)

Photo 1 . During Meeting at Mughan Camp. January 25, 2006.
