**BAKU-TBILISI-CEYHAN
Pipeline Project**

**Report of the Post-
Financial Close
Independent
Environmental
Consultant
Fifteenth Site Visit –
September 2013**

BNP Paribas

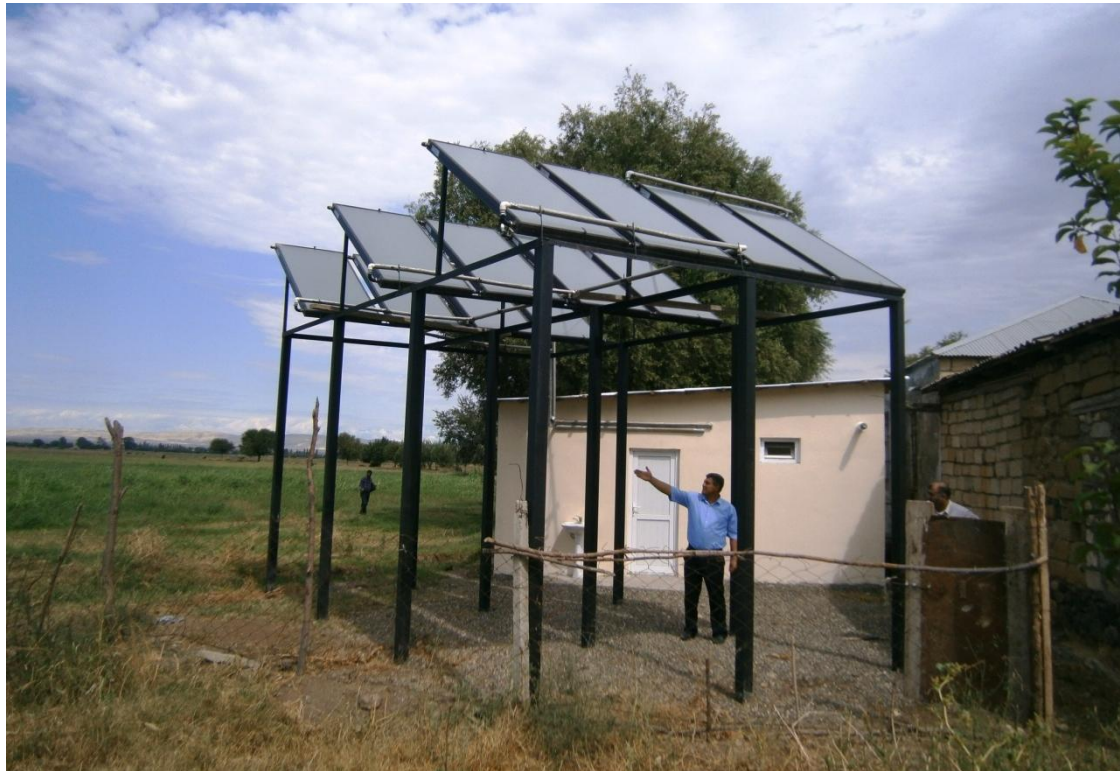
The exceedance of NO_x has been addressed by the Class III MoC discussed in the report from the July 2012 IEC field visit. During this visit, the three schools and the kindergarten where the solar thermal panels have been installed as the NO_x offset program were visited. In the Bashirli Secondary school of Goranboy district, 12 panels have been installed (Figure 2.1), as well as 22 new radiators and hot water storage, water makeup treatment and

additional gas boiler. The cost of the investment was about 42,000 EUR. The system is not yet operational pending a control from the governmental Energy Department.

Figure 2.1: Solar Thermal Panels Installation at Bashirli School

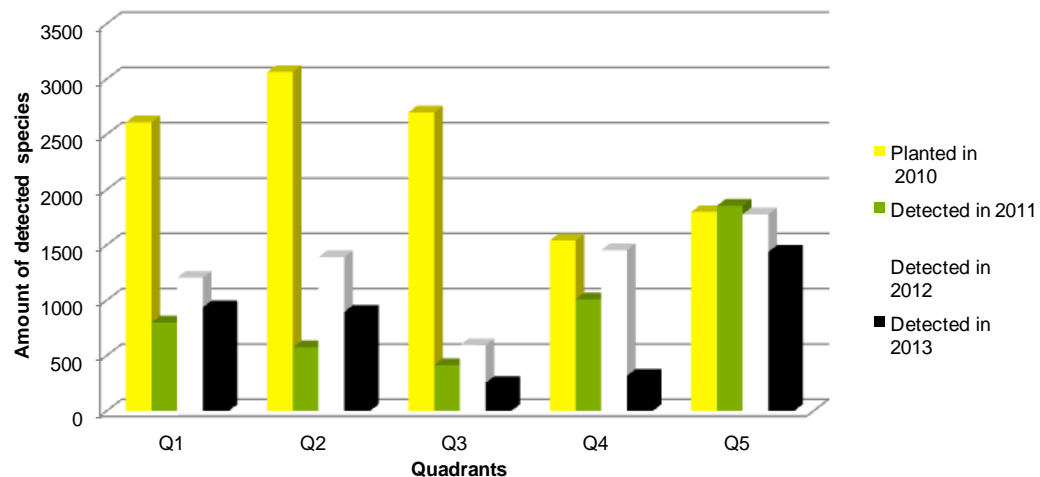
The original plants taken from the RoW, maintained at the Mardakan Arboretum and trans-located back to the RoW have continued to show poor success. The plants trans-located in 2010 from the Garadagh Cement Plant redevelopment area with improved management have shown much better survival percentages, as also shown on Figure 2.6:

- 39.8% in 2011;
- 55% in 2012,
- 33% in 2013.

Figure 2.6: Rare Species Monitoring 2013

The reversal of the population decline is mainly due to a translocation technique adopted by the Project, whereby roots are better protected with surrounding soil. This process that falls in the category of “lesson learned” to be applied with future development.

1. Start the plantings that comprise the *Iris Acutiloba* offset. This program is late. . The reason for being late in planting of red book listed trees to compensate not survived *Iris Acutiloba* plants was high cost proposal made by contractor company (650 K- 700K which is not reasonable and acceptable cost for this project. That’s why then it has been decided to plant 32000 *Iris* Plants on RoW which will not be deteriorated by EPPD. Negotiation with contractor has already started)

2. Continue with the program of reinstatement the *Iris acutiloba* with their original soil. Some last attempts (2012 – 2013) seem to have produced better results than in the past with this technique, as visible in a recent reinstatement areas near to KP12. Even considering some success in re-planting this red listed plant, at this stage it cannot be considered a replacement for the offset. As mentioned above the company has decided to plant back 32,000 plants instead of planting of trees. The cost for planting trees is not acceptable and reasonable.

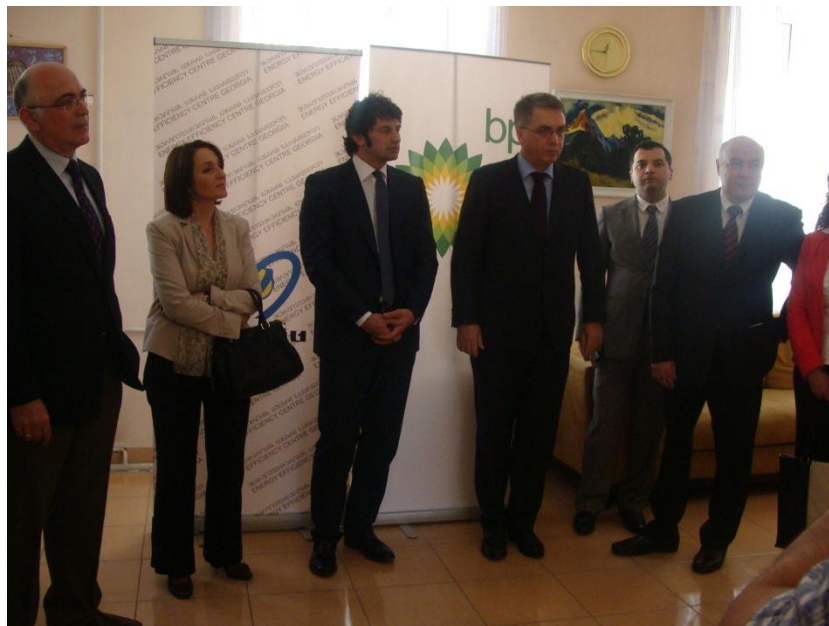
water heaters in schools similar to the program in Azerbaijan. This program is discussed in the IEC report for the July 2012 field visit and is not repeated here. One change since July 2012 is that the third project, Borjomi Micro Hydro Power Plant (intended to produce renewable clean electricity to be used by Borjomi Park) was not practical to undertake for a variety of reasons and was replaced by another solar thermal system project at “Baby House” in Tbilisi. This facility seeks to improve sanitary norms for baby care (158 infants) and their living conditions. The project has also included installing energy saving measures such as insulation of the attics, replacement of old wooden windows and doors with double glazed equivalents in PVC frames, and replacement of incandescent light bulbs with energy saving bulbs. The project has been successfully completed and replacing the Borjomi project with this new solar heating project is considered acceptable to the IEC and we consider the offset to now be complete.

Figure 3.4: Tbilisi “Baby House” presentation for last offset project

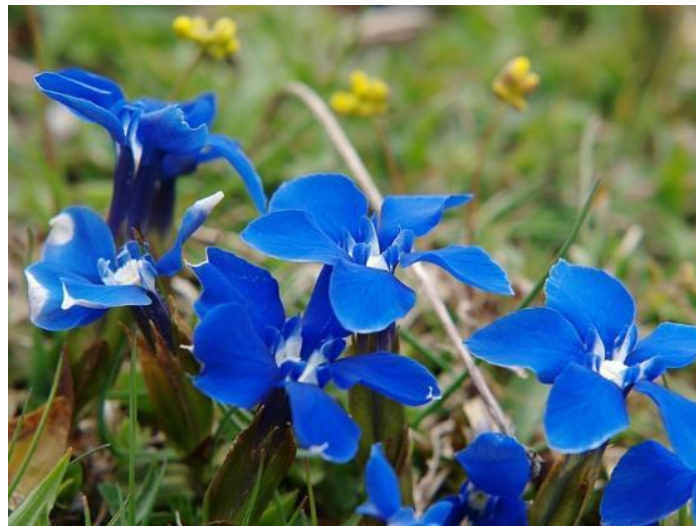
Figure 3.5: *Gentiana angulosa* (Gentian) planned for second re-introduction on pipeline RoW

A component of the pipeline RoW reinstatement has been the re-introduction of rare floral species with the objective of re-establishing a minimum of 75% of the original population within the areas designated for translocation. This indicator has been achieved with 8 species out of 11, of which two species are considered significant, *Gentiana angulosa* (Gentian) and *Fritillaria lutea* (Fritillary). These species were originally present in the Tskhratskaro (KP 176) and Kodiana (KP 193) passes, but were found to be absent after surveys in 2009. In particular, approximately two thousands of Gentian individuals were planted in these areas, but did not survive. Since 2009, seeds and bulbs of these species have been cultivated such that they can be again introduced, but with what is expected to be an improved approach for their re-introduction, currently planned for September 2013⁴. Monitoring will be then performed in summer 2014.

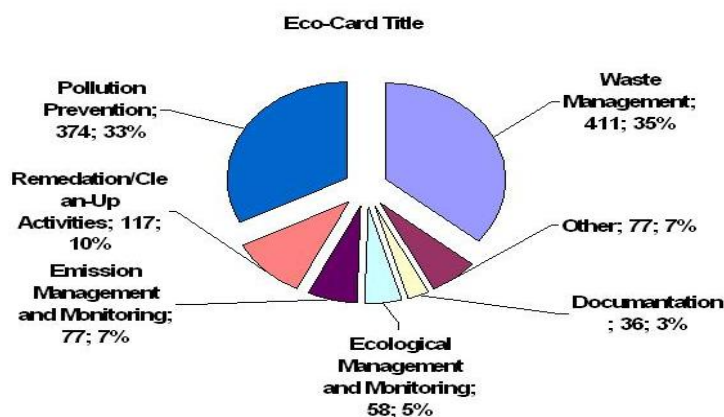
Environmental tracking and performance is now a routine part of environmental and social management in Turkey, as reported in past IEC reports. One component of this system that we believe is exceptional, as we do not commonly see this system on major development projects, is the Environmental Compliance Observation (ECO) system where employees and visitors are encouraged to make environmental observations that can be reported to management by filling out a card (ECO-CARD). This relatively new system supports environmental management by identifying areas where improvements can be focused (see Figure 4.1).

Figure 4.1: ECO-CARD Recorded Data up to September 2013

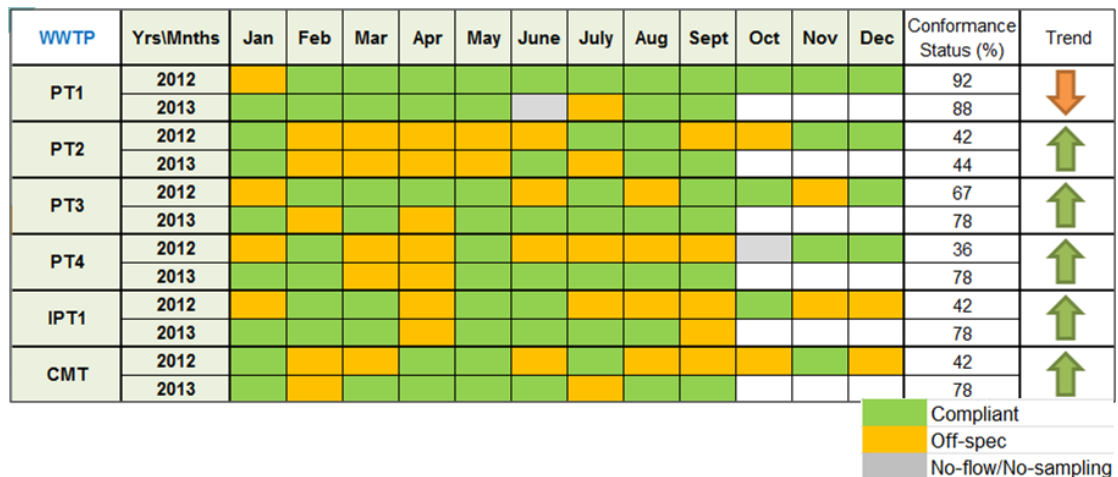
As a result of recent efforts there has been significant improvement in the performance of the WWTPs (Figure 4.2). In the few cases where effluent does not meet Project standards, it can either be recycled or trucked to Project-approved Municipal WWTP for further treatment. Effluents have generally been compliant since June 2013 except for IPT1 (had two excursions in 2013). Effluent not meeting standards is not discharged to the environment.

Figure 4.2: WWTP Effluent Compliance

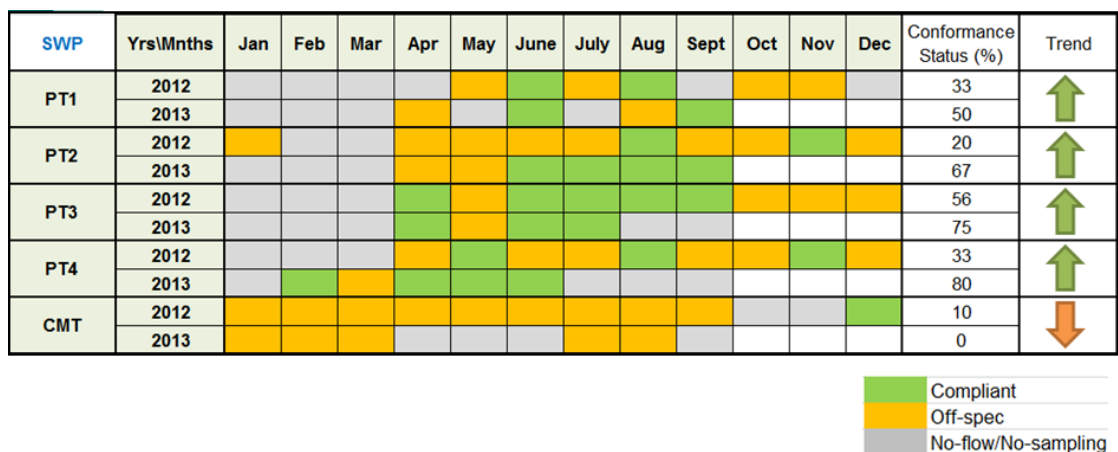
Most of the improvements planned for the SWP and PWHP systems discussed previous IEC reports were completed in 2013. WWTP effluent no longer has to go to an SWP if it is a compliant discharge, as appropriate bypass valves and pipes have been installed. The PWHPs receive OWS effluents that are then sent to a SWP; sliding gate valves between the PWHPs and SWPs are now installed to avoid SWP contamination in case of oil spill or PWHP non-compliance in general. The SWPs now have submersible pumps. Direct discharge lines and valves for PWHPs are currently being considered for cases when these ponds are capable of compliant discharge. All of these changes are significant improvements in terms of managing spills and effluents, but there is still room for improvement, especially at CMT (Figure 4.3).

The leak from the bottom of the PWHP at PT3, which was already identified in 2011, is not fixed yet, but increased groundwater testing does not indicate that groundwater is being contaminated. The solution to this problem is being evaluated and may be tied into a general MoC to line all of the retention ponds with concrete

Figure 4.3: SWP Pond Compliance

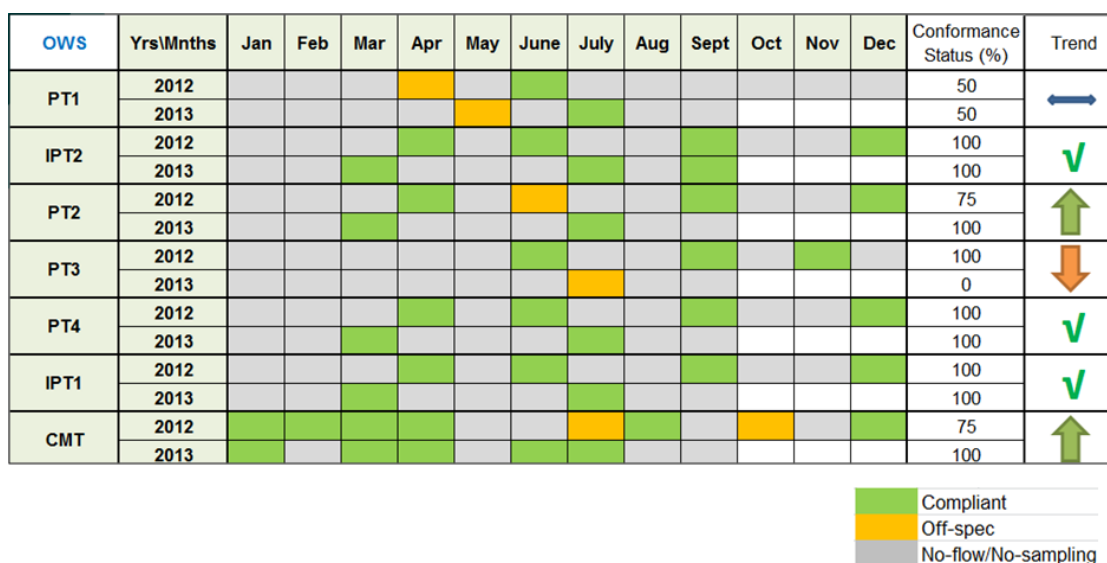
OWS effluent compliance is generally good (Figure 4.4). Again, it is emphasized that off-spec effluent is not released to the environment.

Figure 4.4: OWS Effluent Compliance

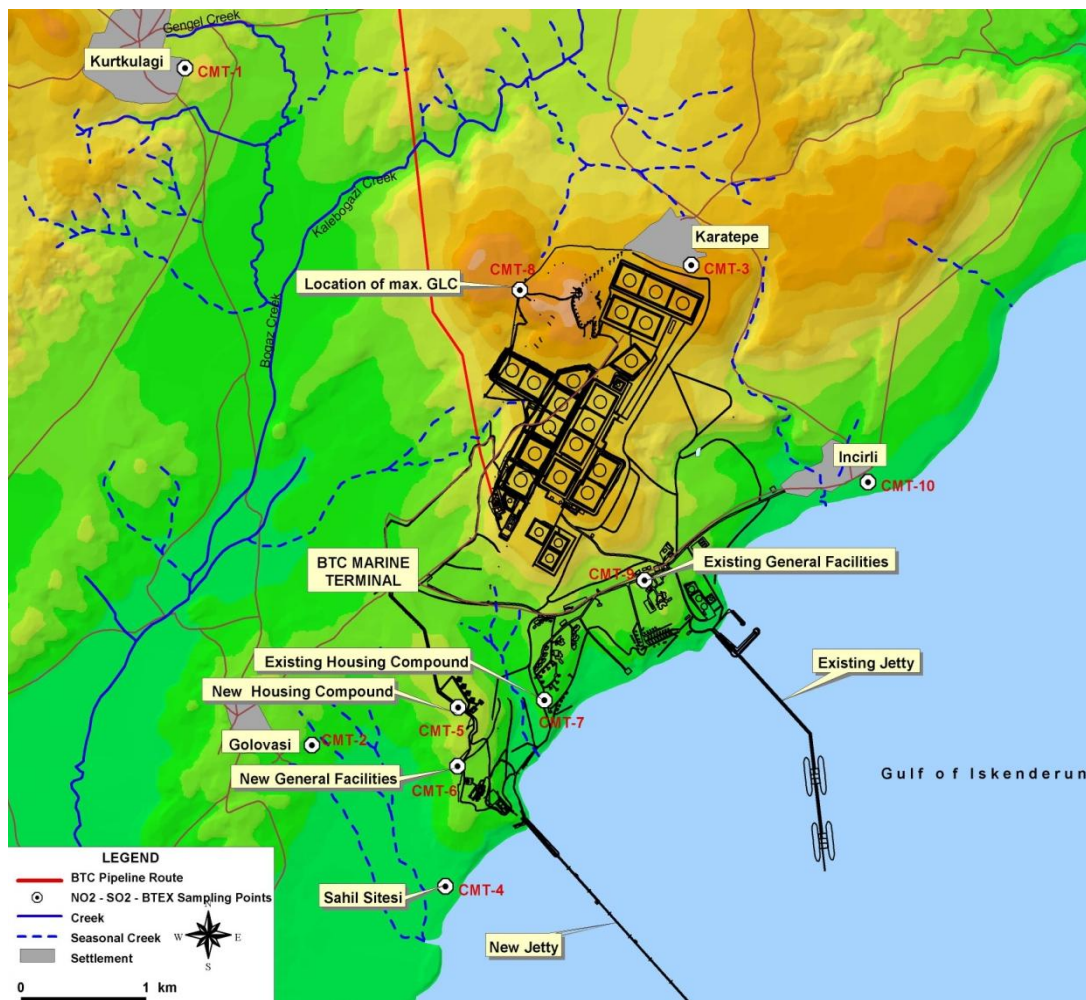
Ambient air quality monitoring is undertaken only at the CMT and takes place at 8 locations four times a year. NO_x, SO₂, and Benzene, Toluene, Ethyl benzene and Xylenes (BTEX) parameters are monitored. Although some BTEX excursions were recorded in 2010 and 2011 ambient air quality has never been an issue. All of the readings for spring 2013 have been lower than the project specifications standards and Turkish regulations, with the exception of the monitored value of toluene concentration at CMT8, which was measured in 84.98 µg/m³ versus a Turkish regulation limit of 75 µg/m³. It should be noted that monitoring point CMT-8 is intensively affected by the adjacent Botaş facility. There were no excursions of any of the ambient air parameters in all of 2012.

Figure 4.5: CMT Air quality Monitoring Locations
