Technical Briefing

Deepwater Horizon Incident Response Update

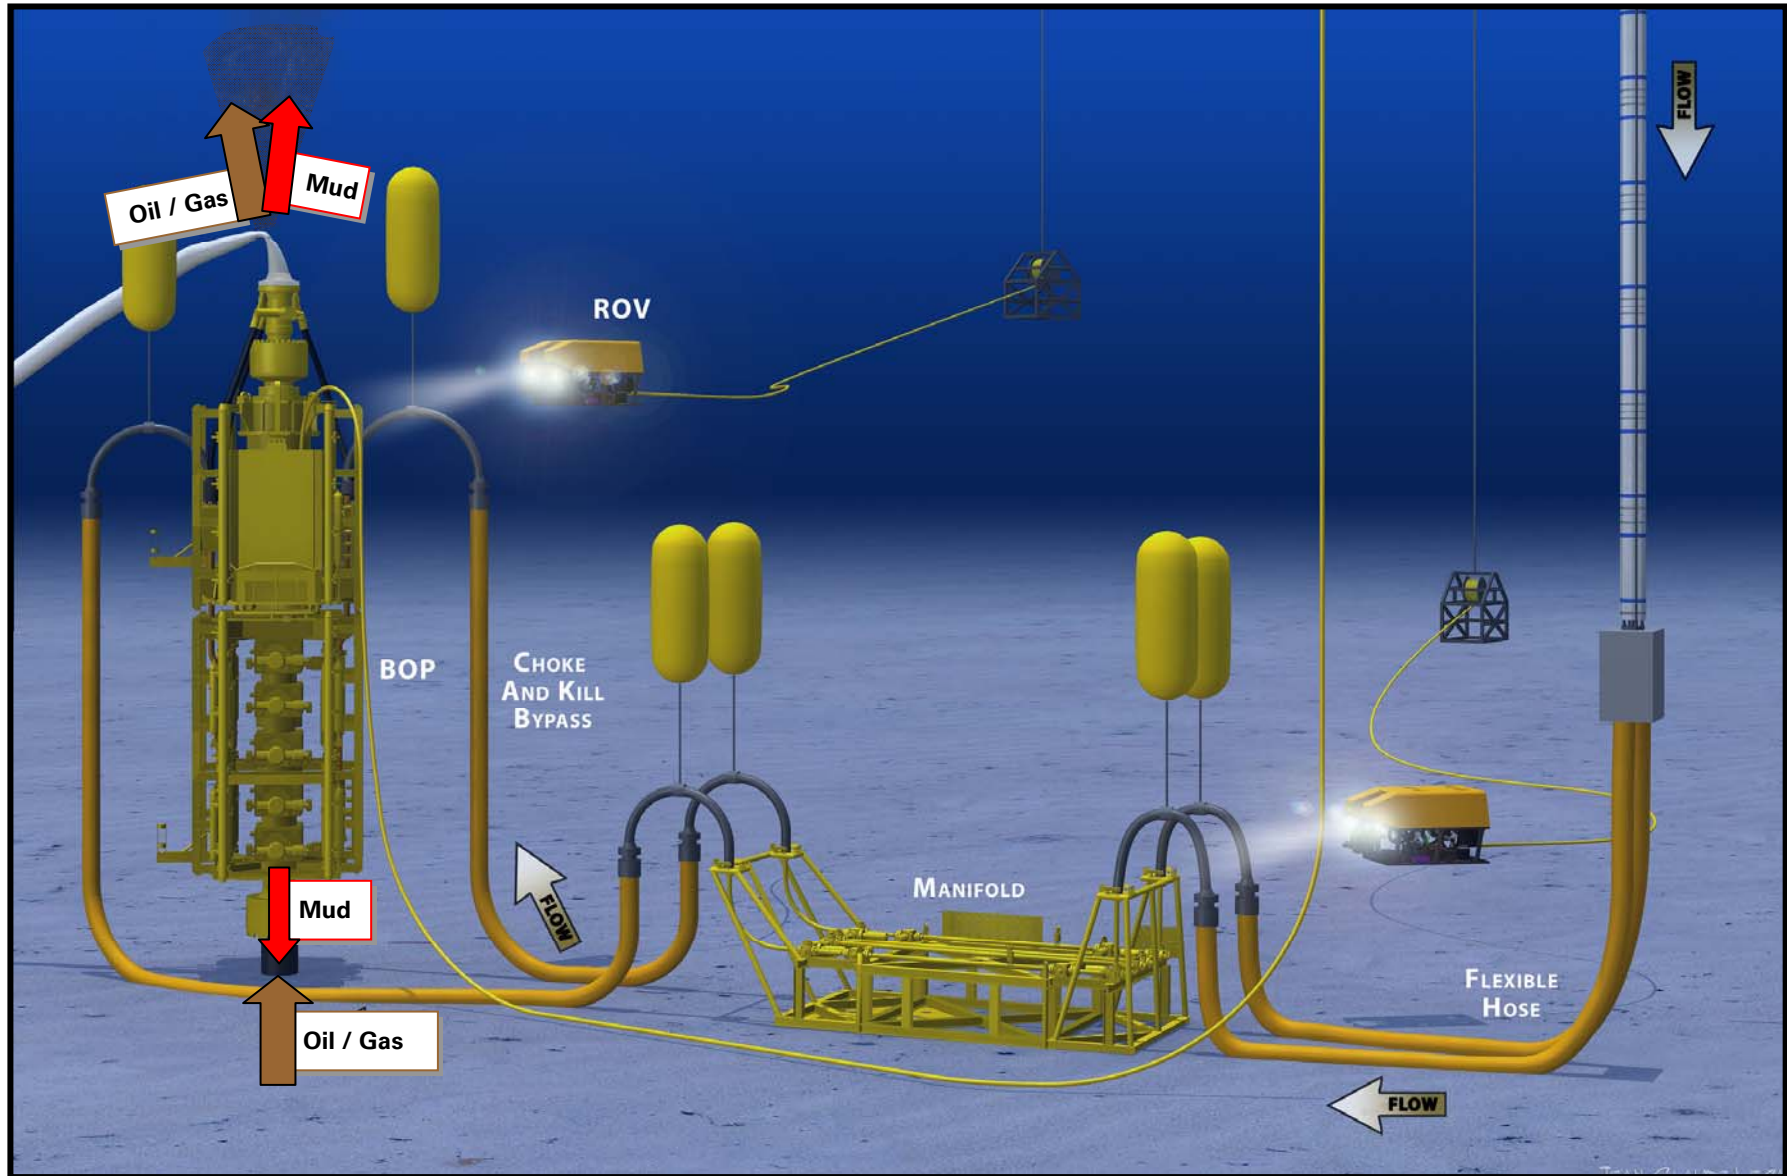
Top Kill Results

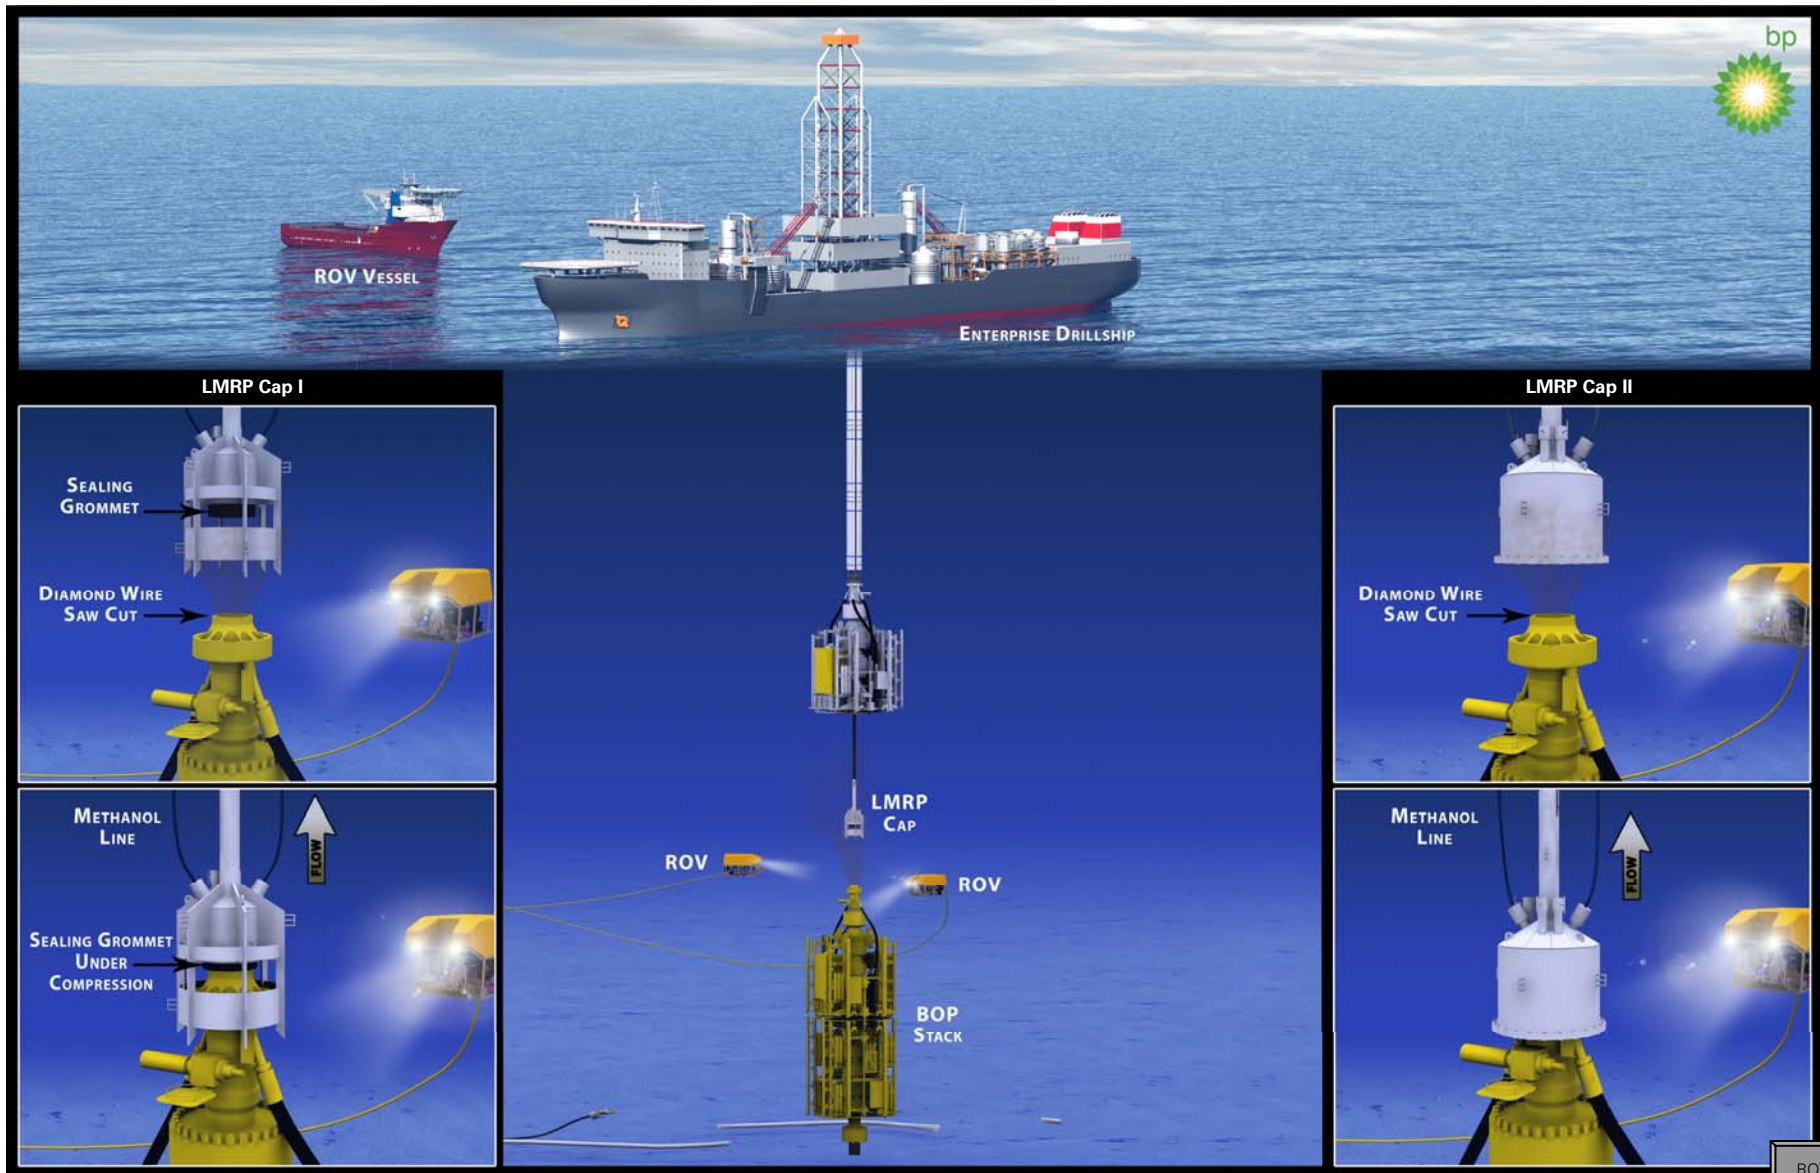
LMRP Cap I and II

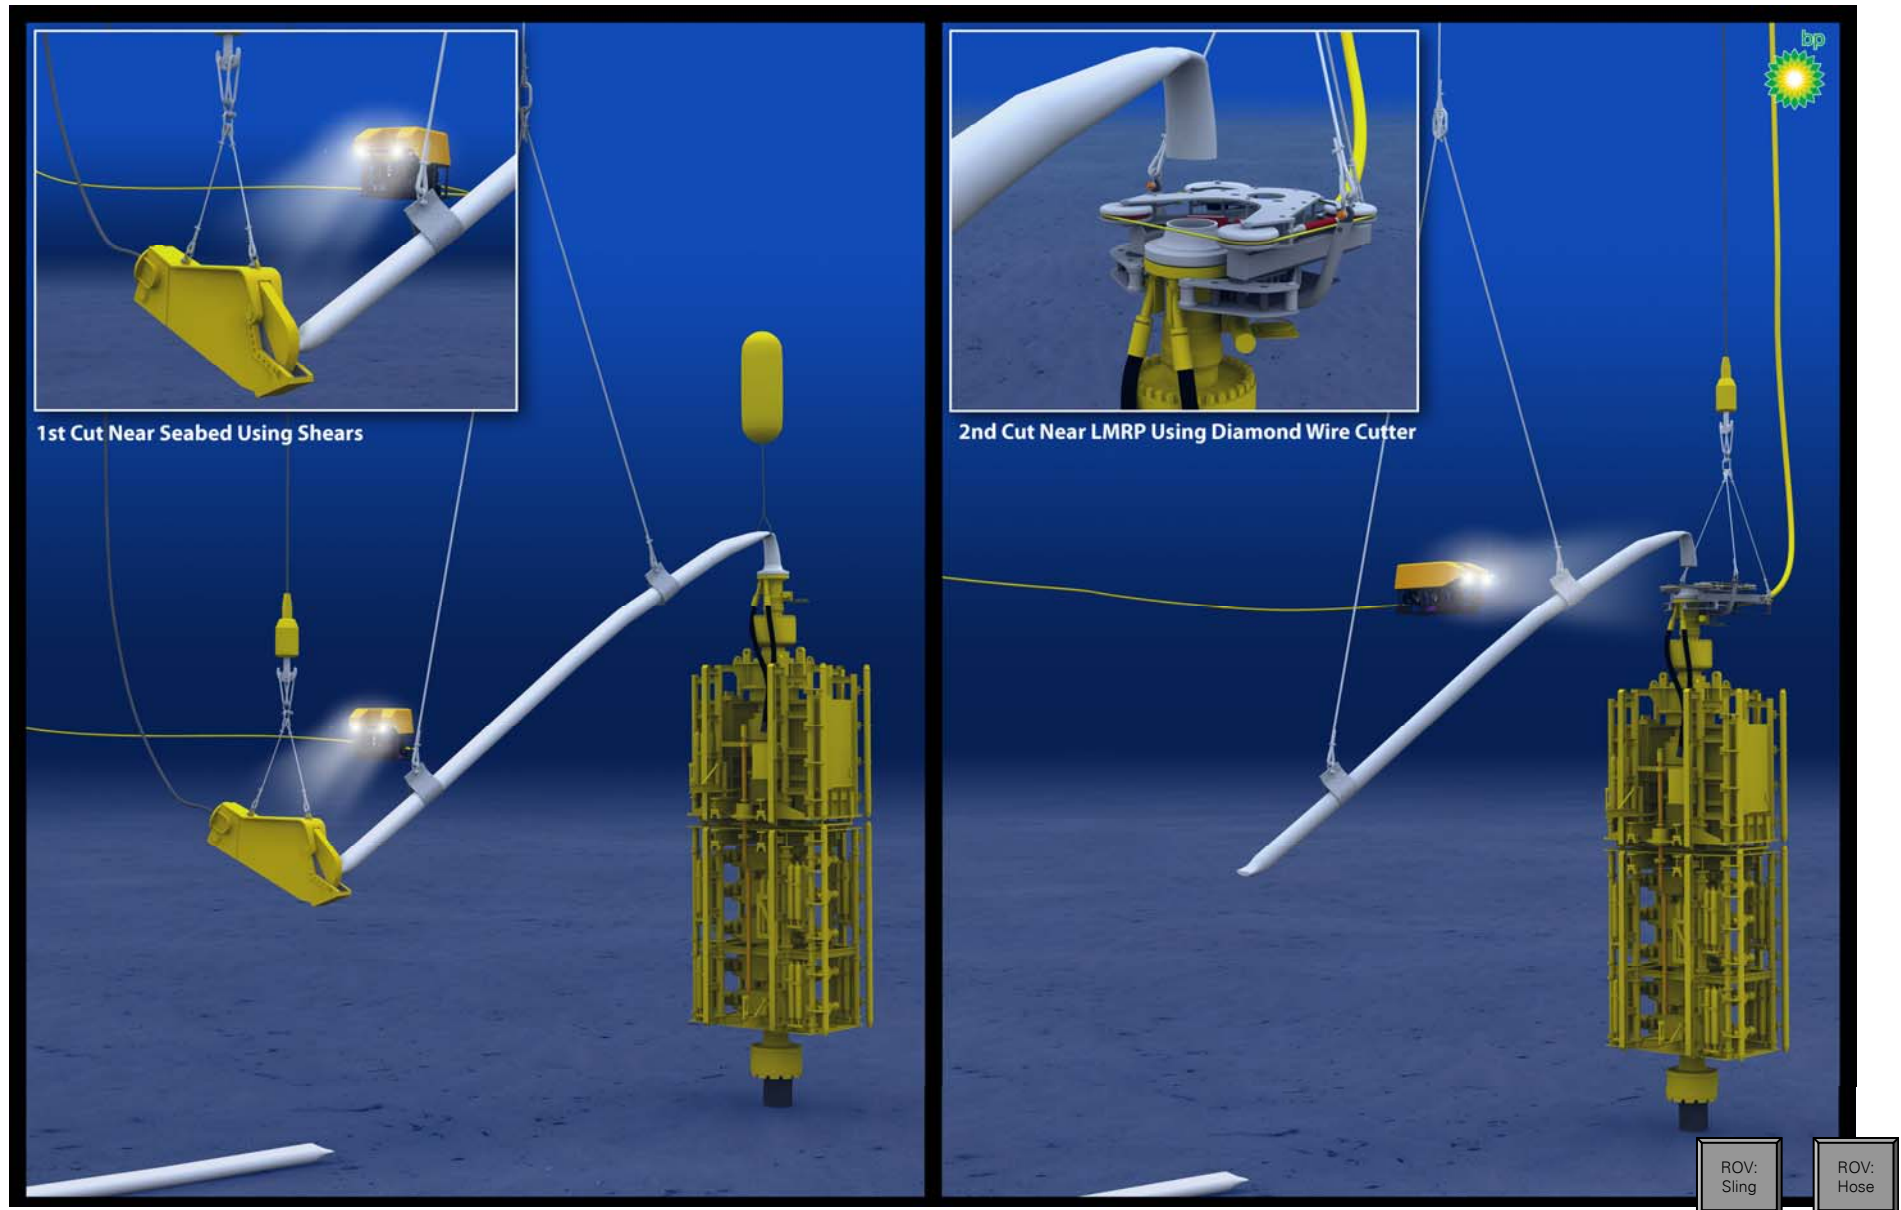
ROV: Move

Riser Removal – 2 Step Process

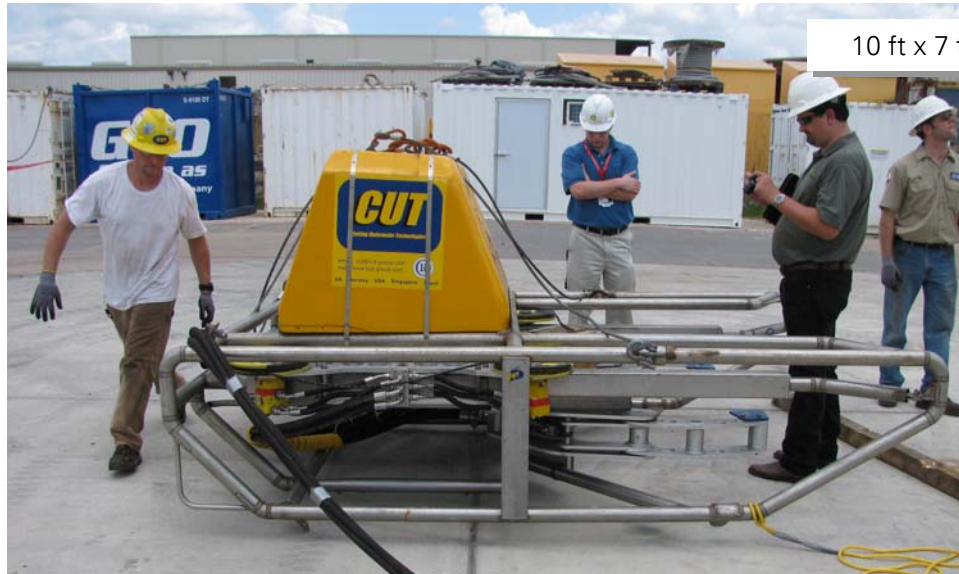
Diamond Saw

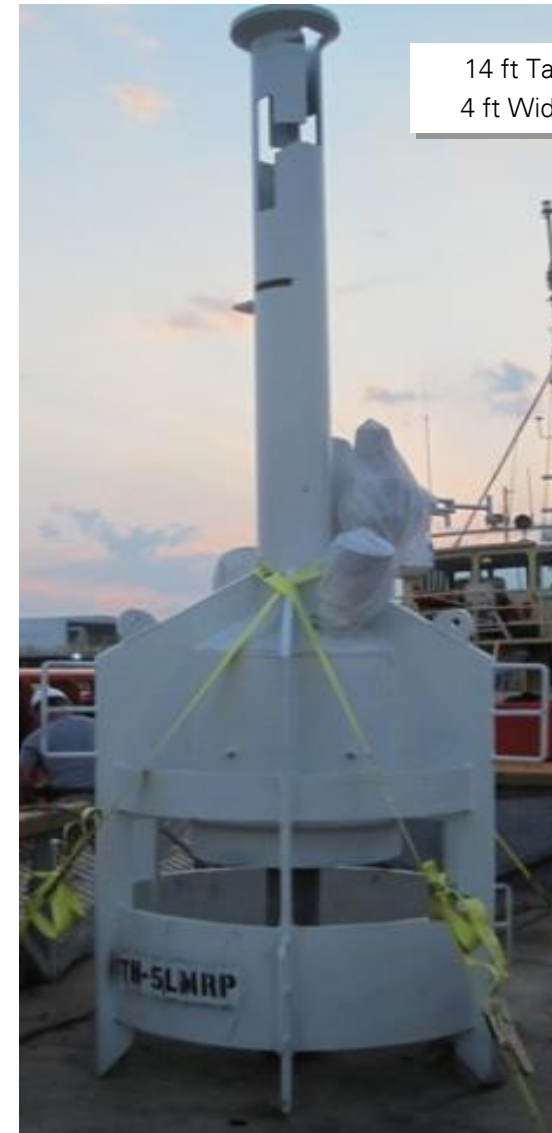
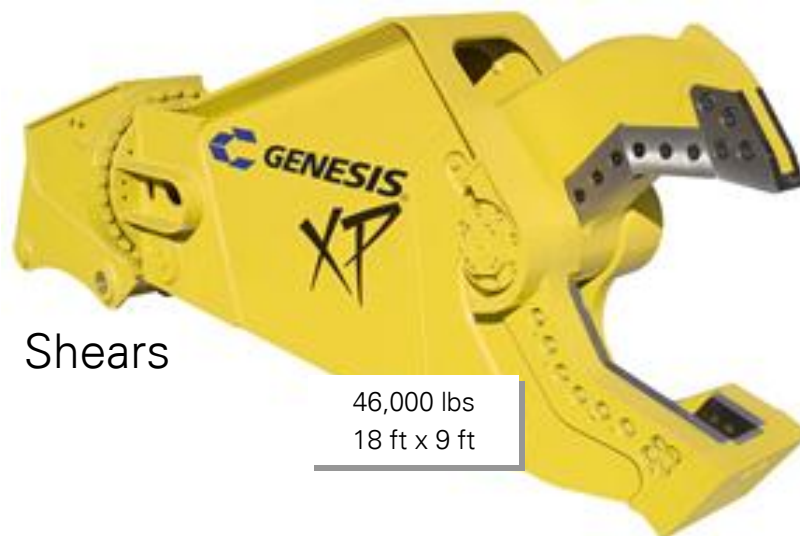
LMRP Cap Prior To Deployment

Shears

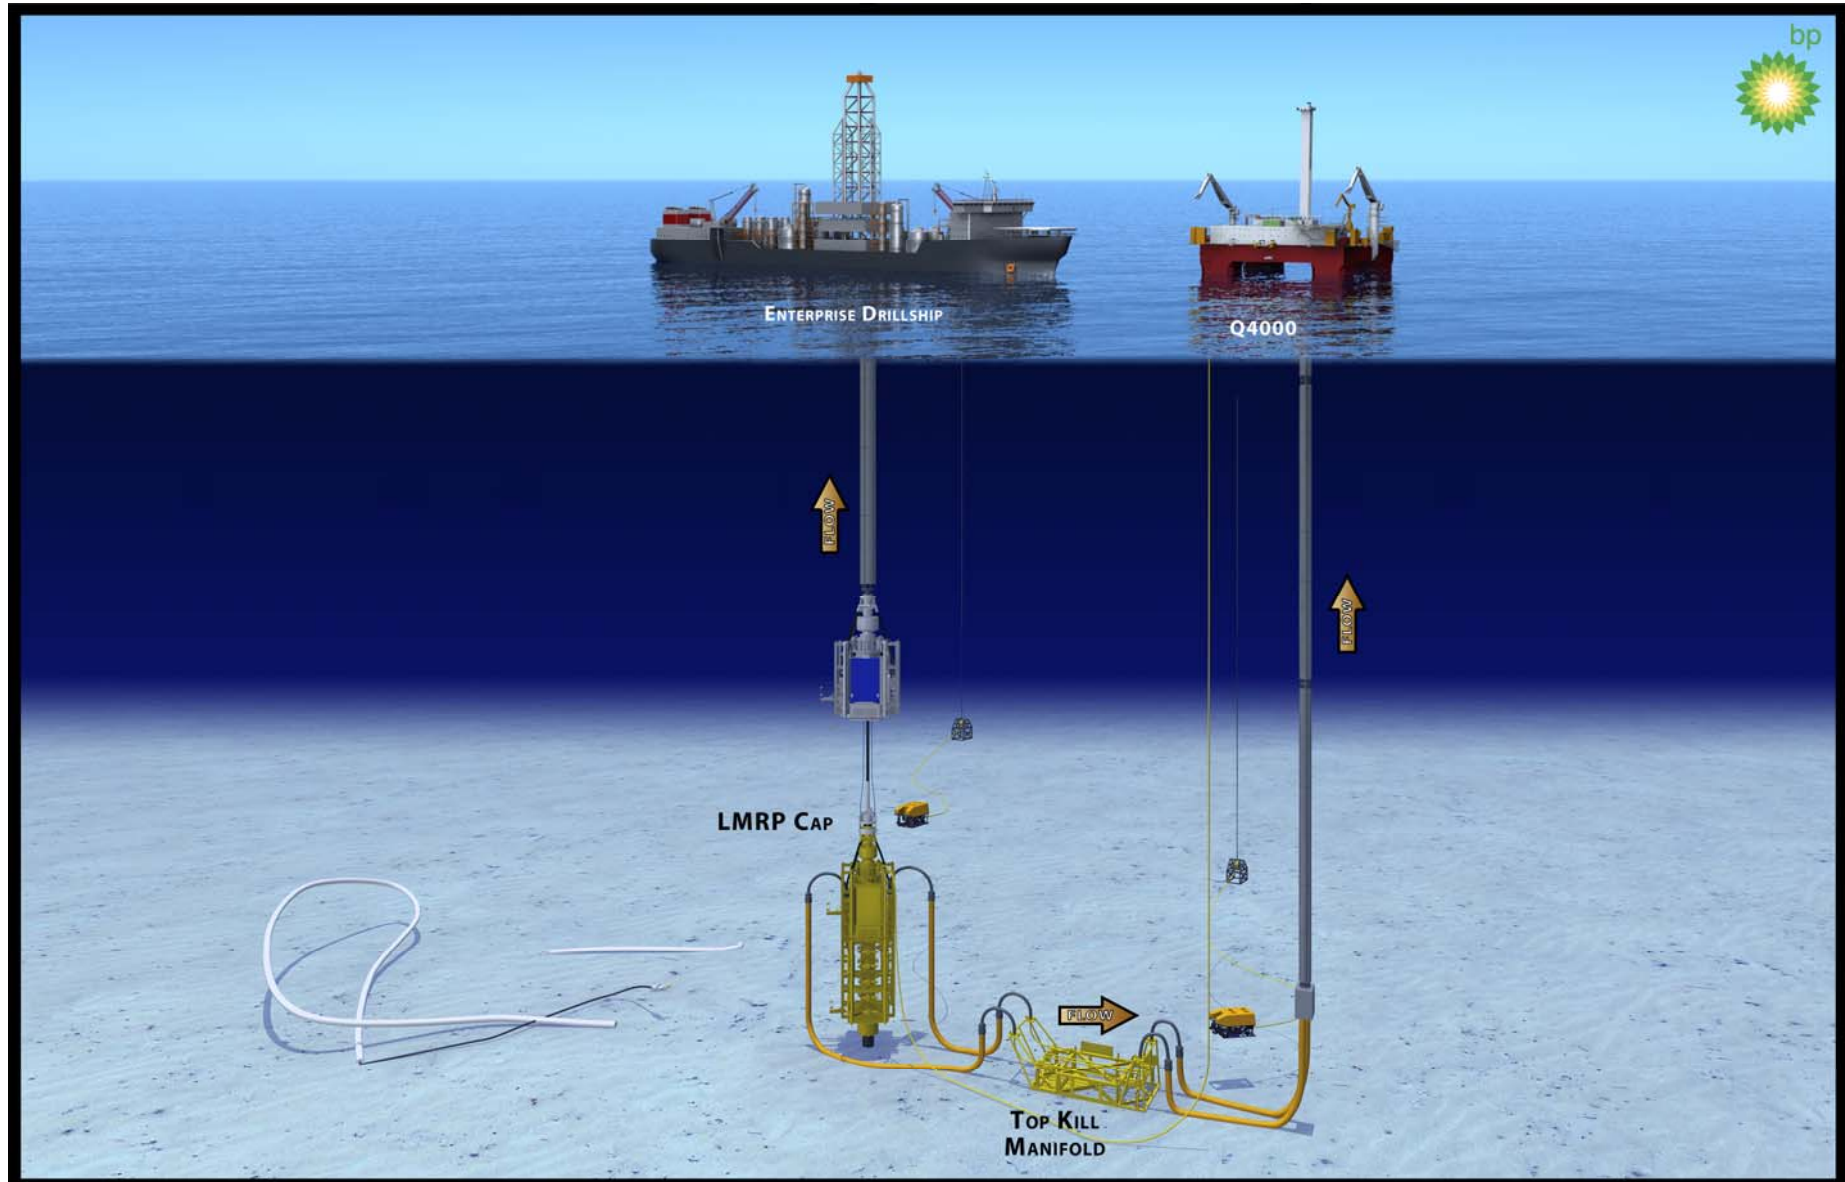
Double Containment: LMRP Cap w/ Q4000 Direct Connect

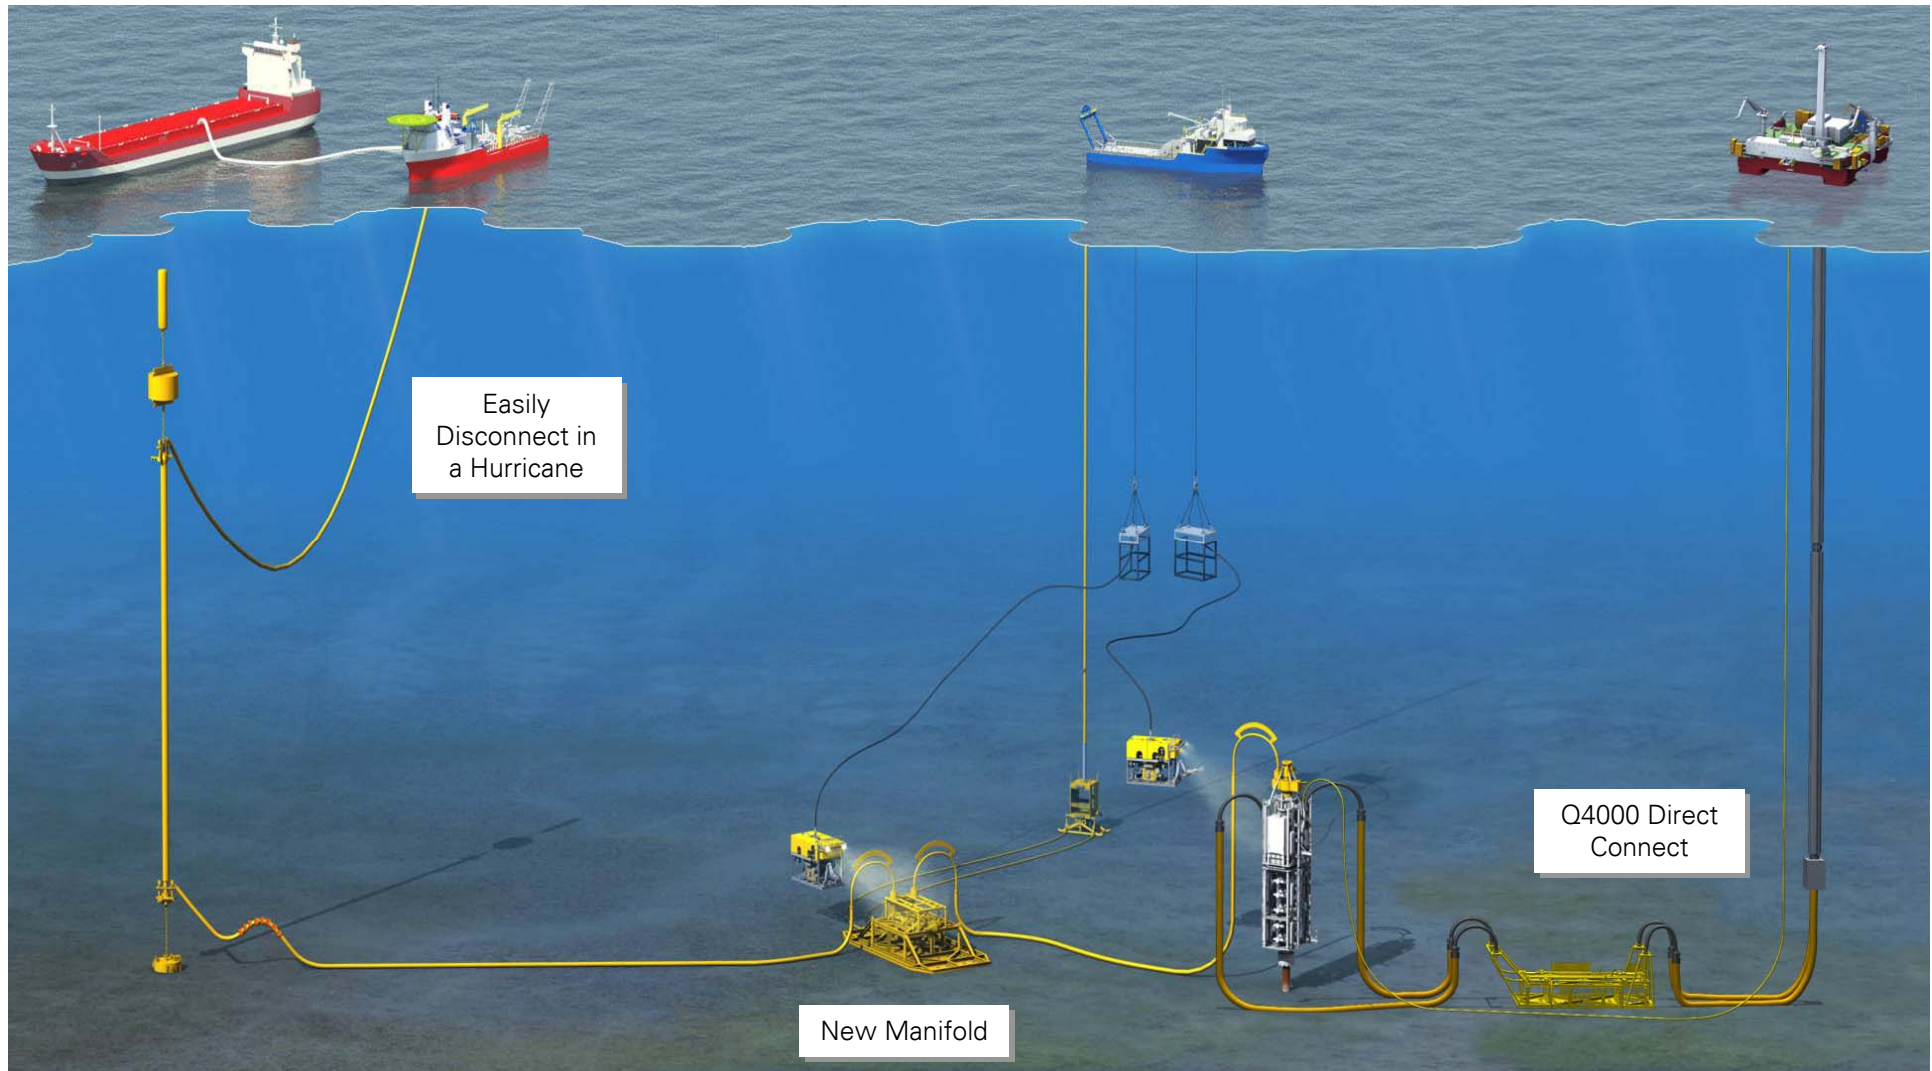
Long Term Containment

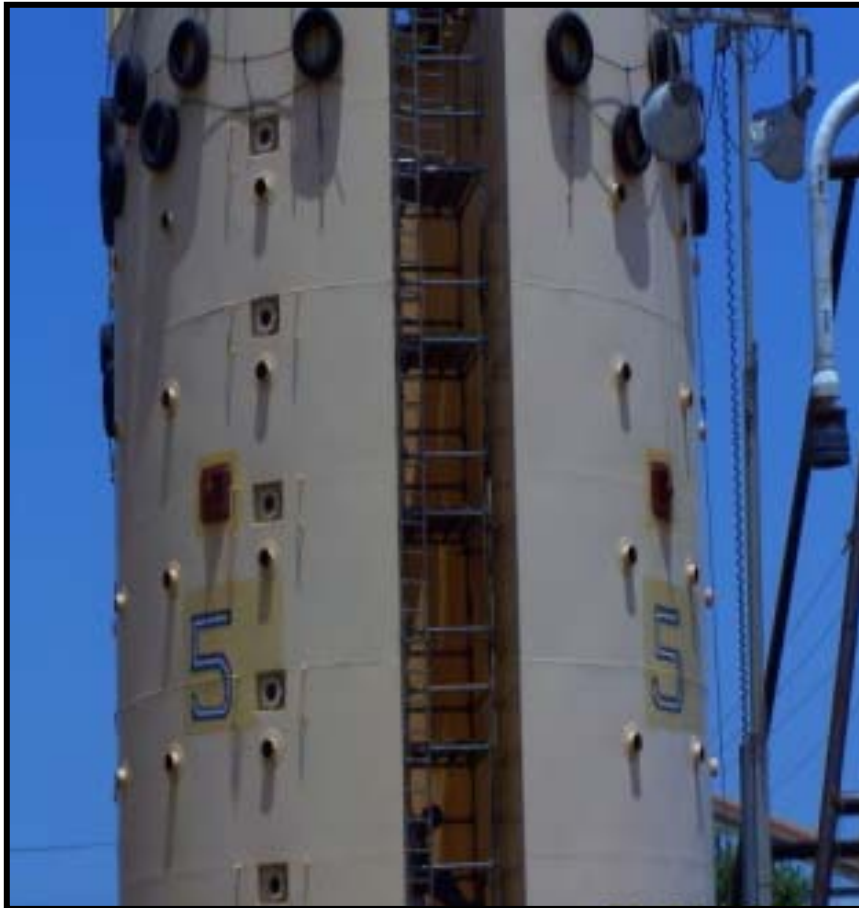
Buoyancy Can

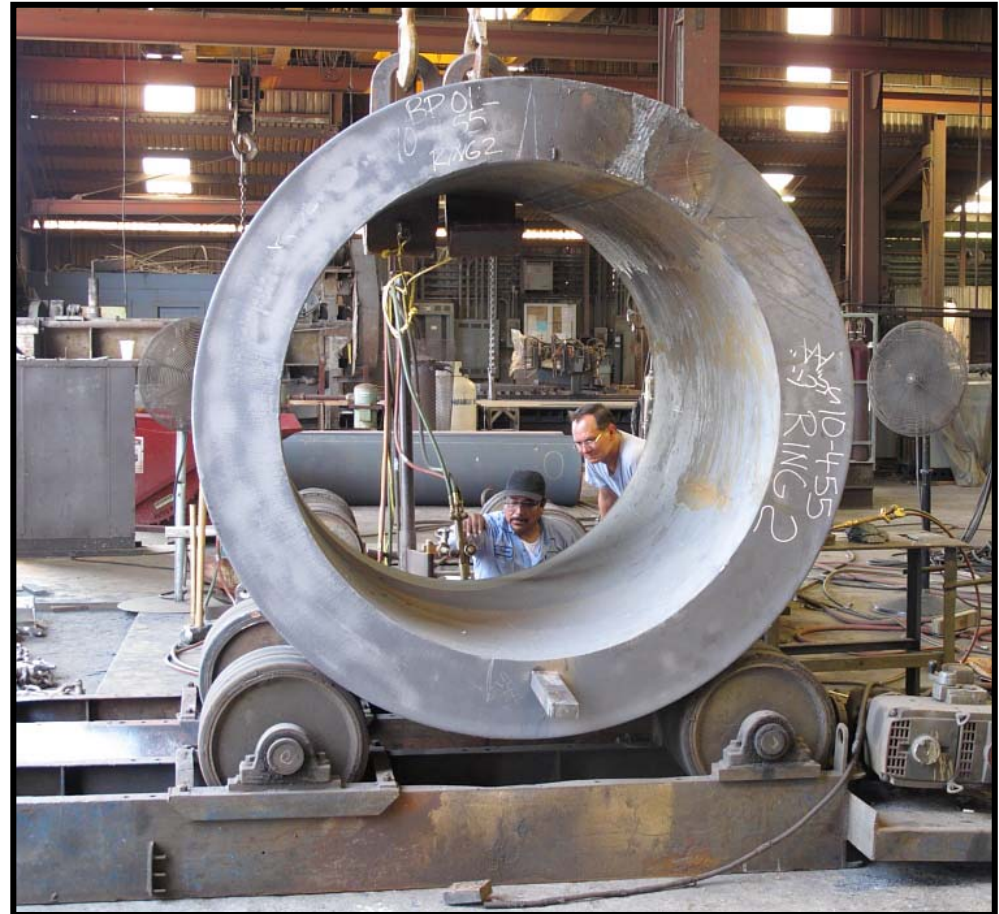
Overshot Tool

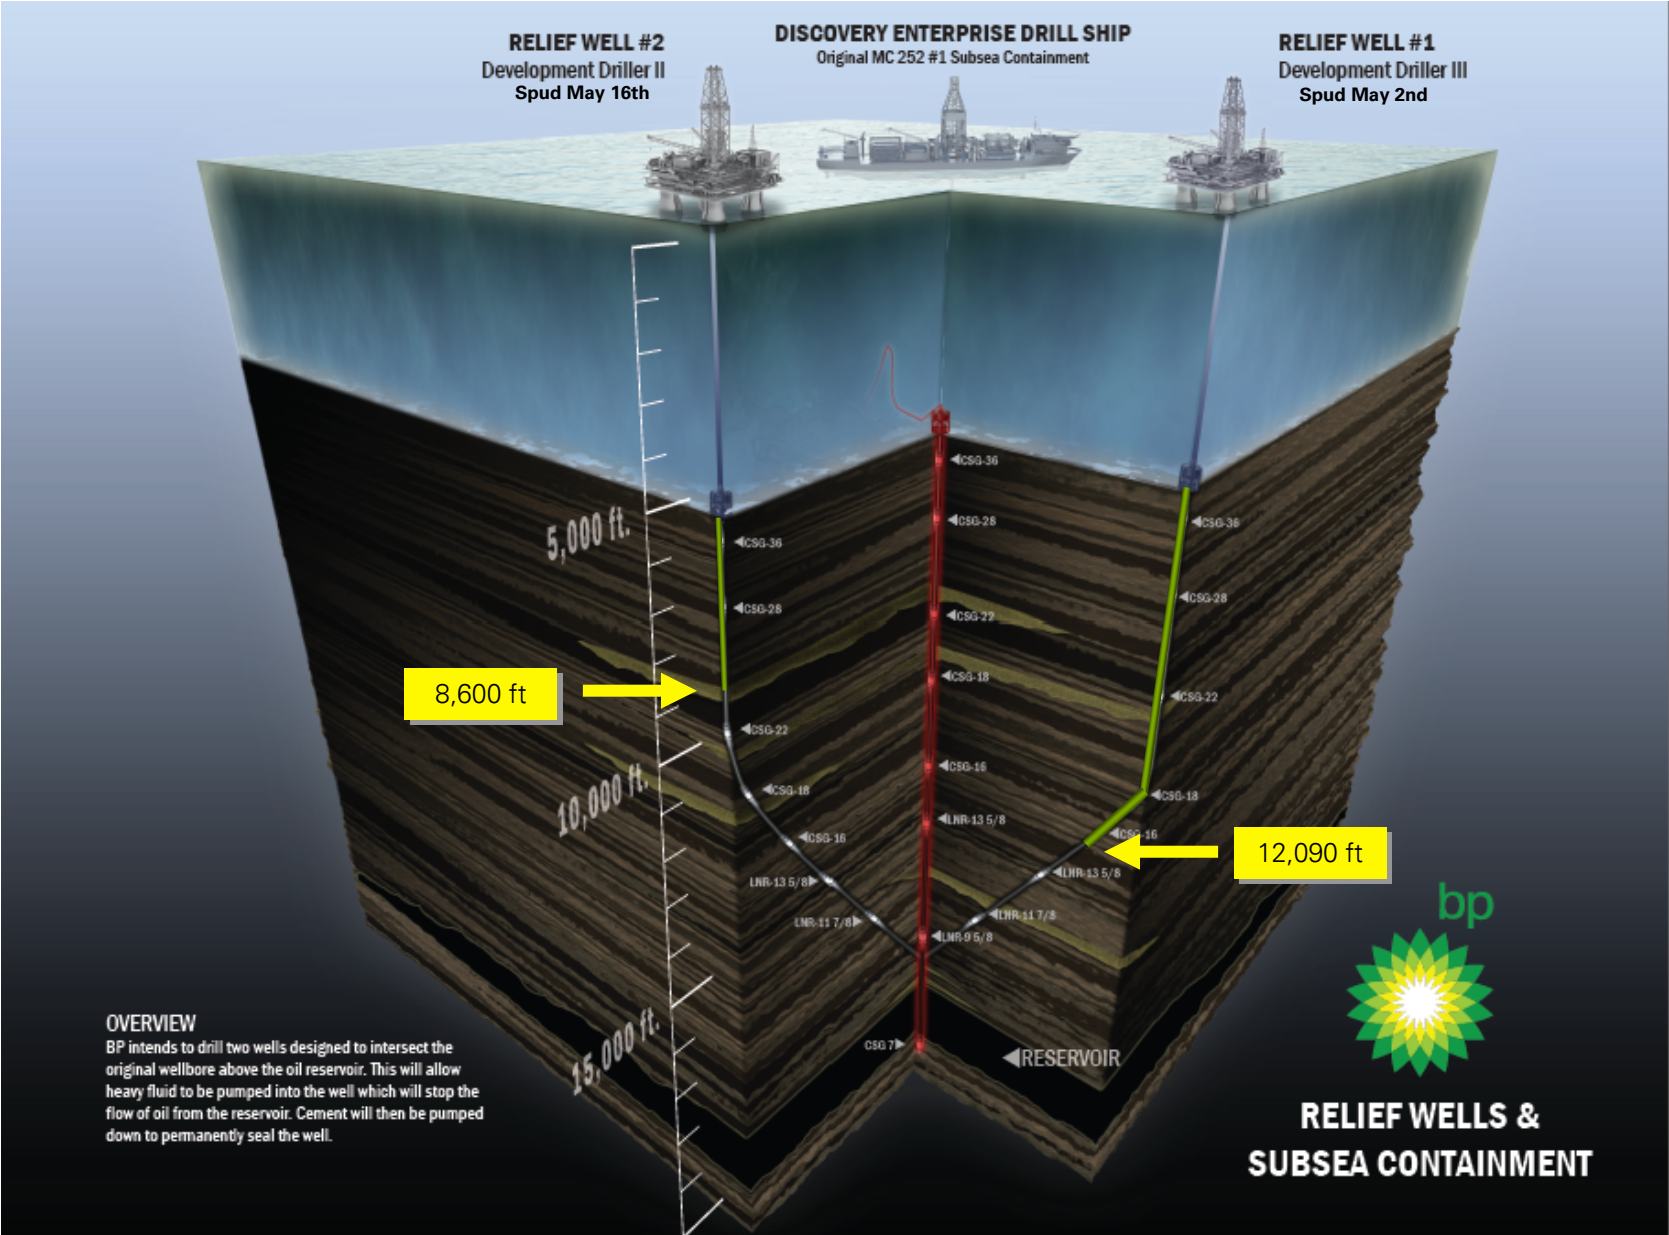
Relief Well Progress

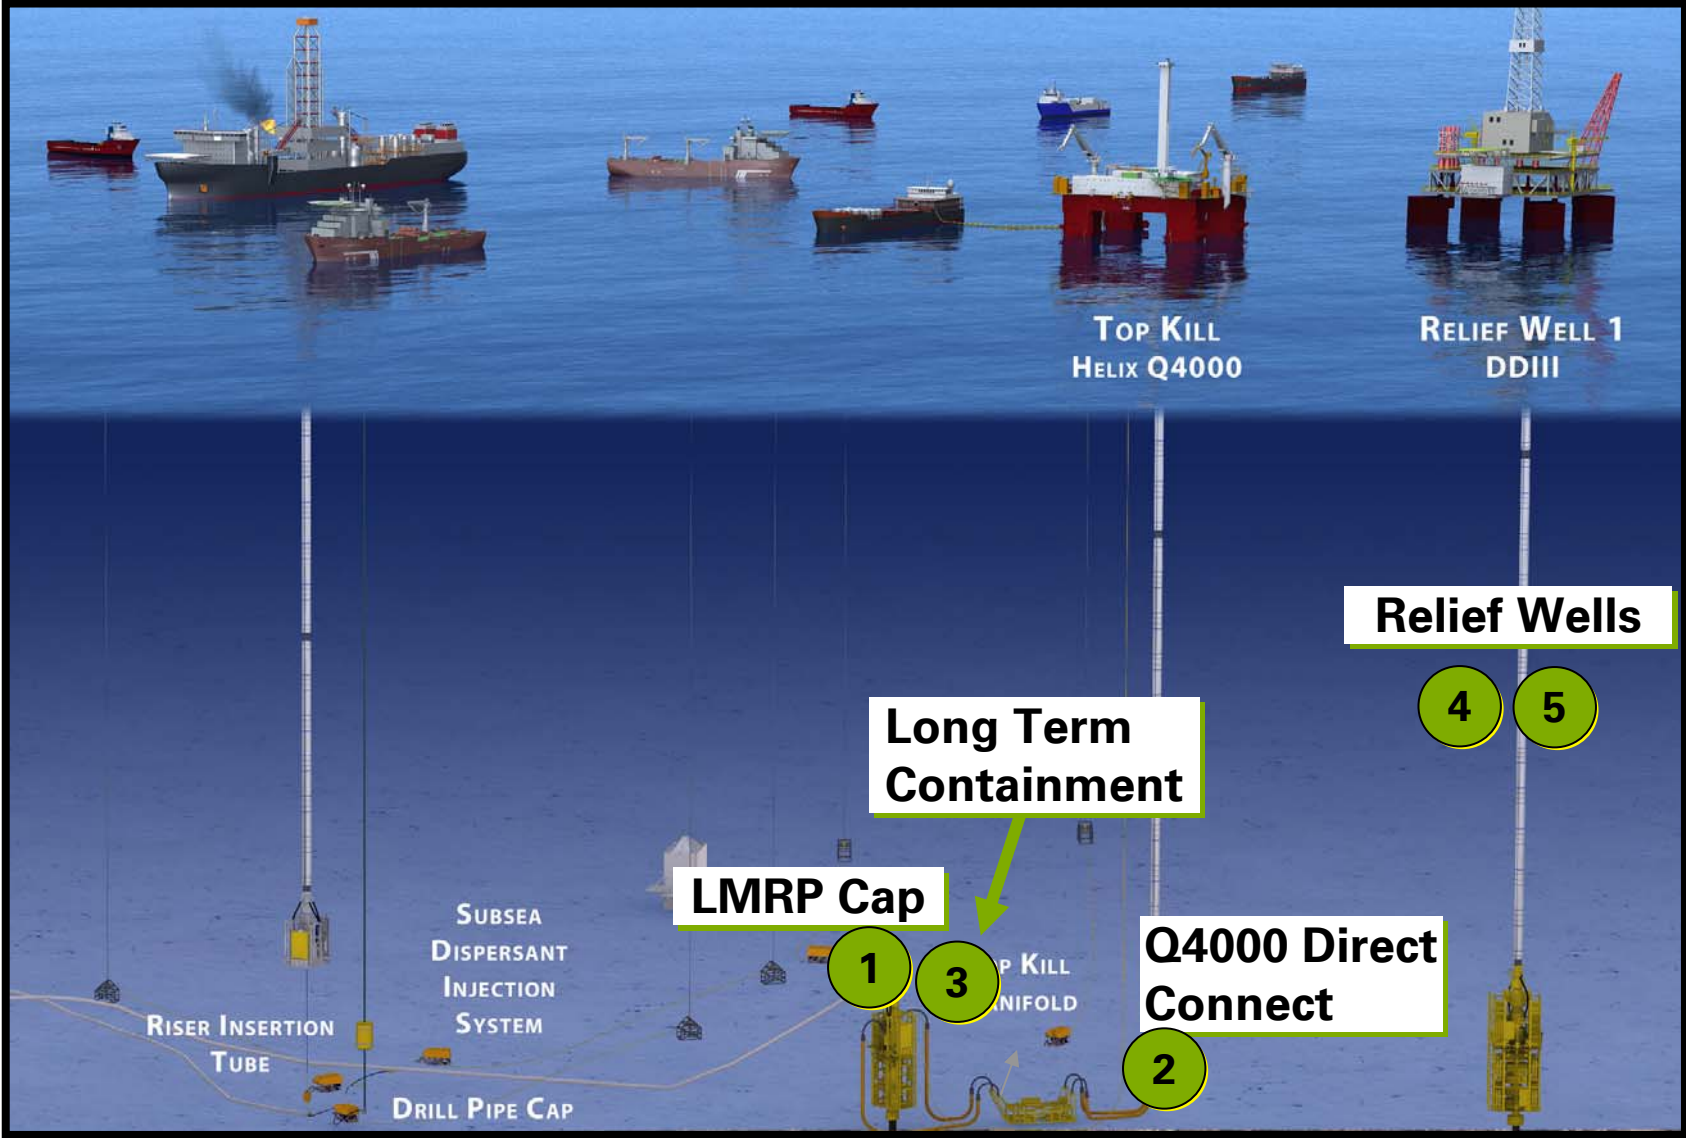
Multiple Containment and Relief Efforts Continue
